A.A. ANDERSON LODGE CONDITION ASSESSMENT

A.A. Anderson Lodge
Shoshone National Forest
Wyoming

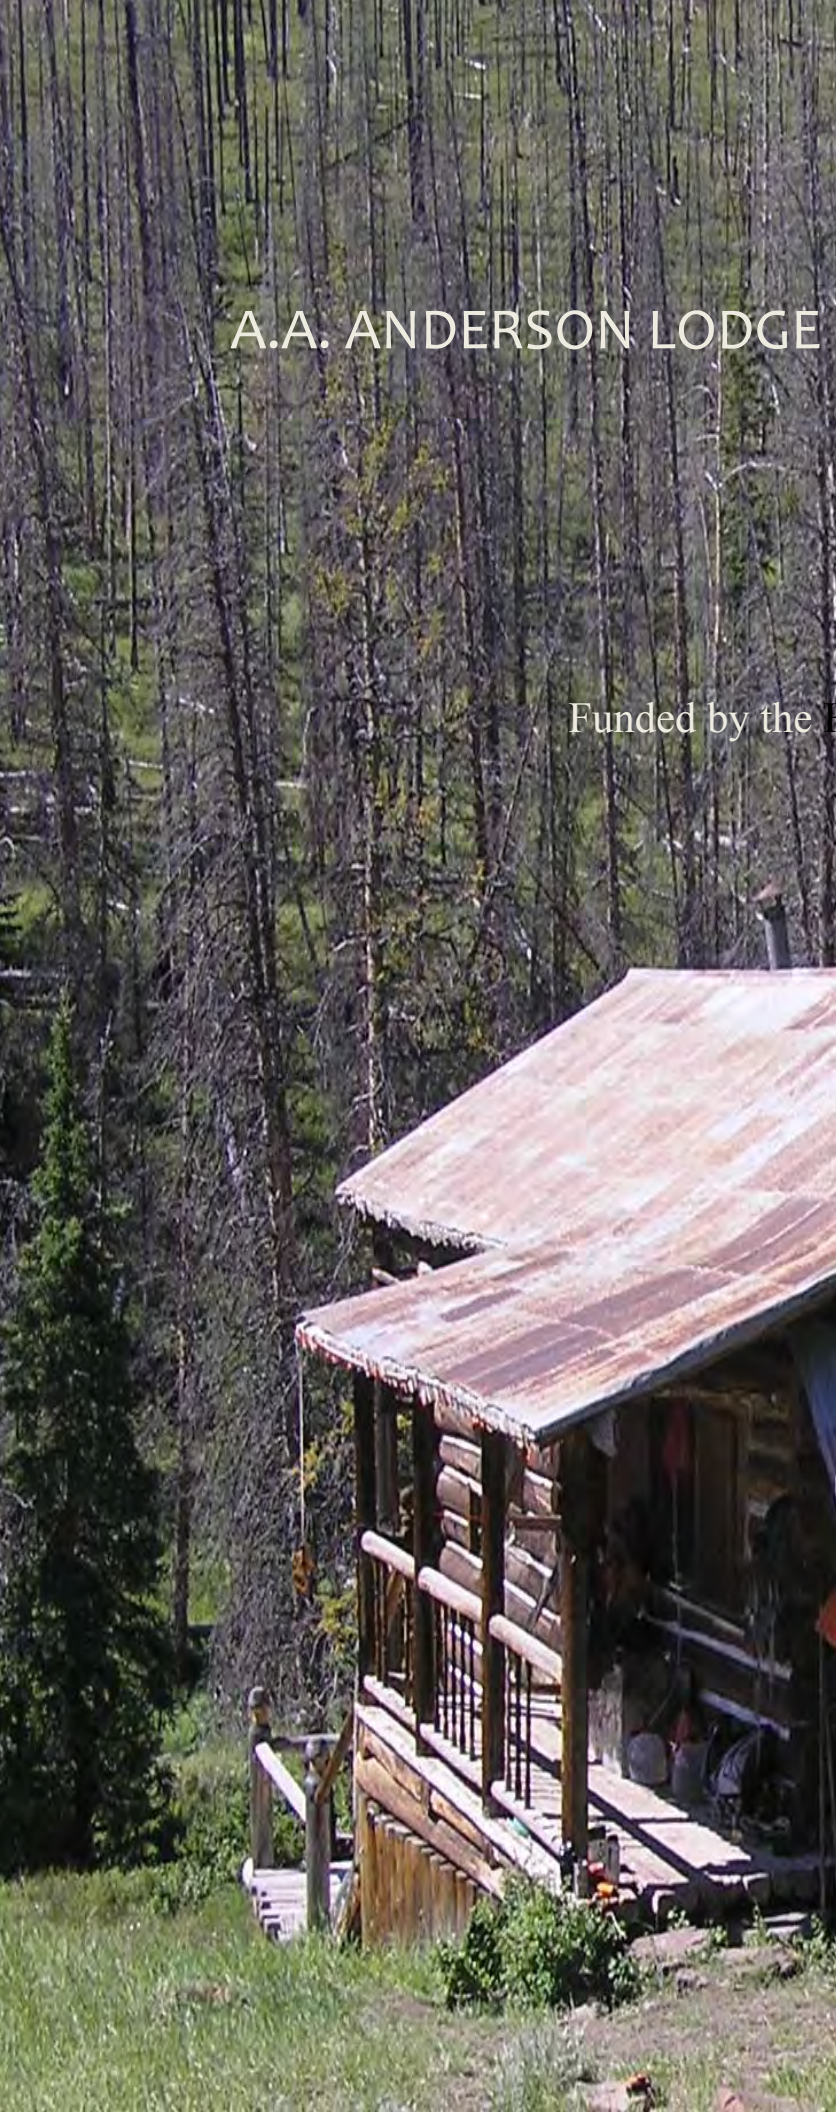
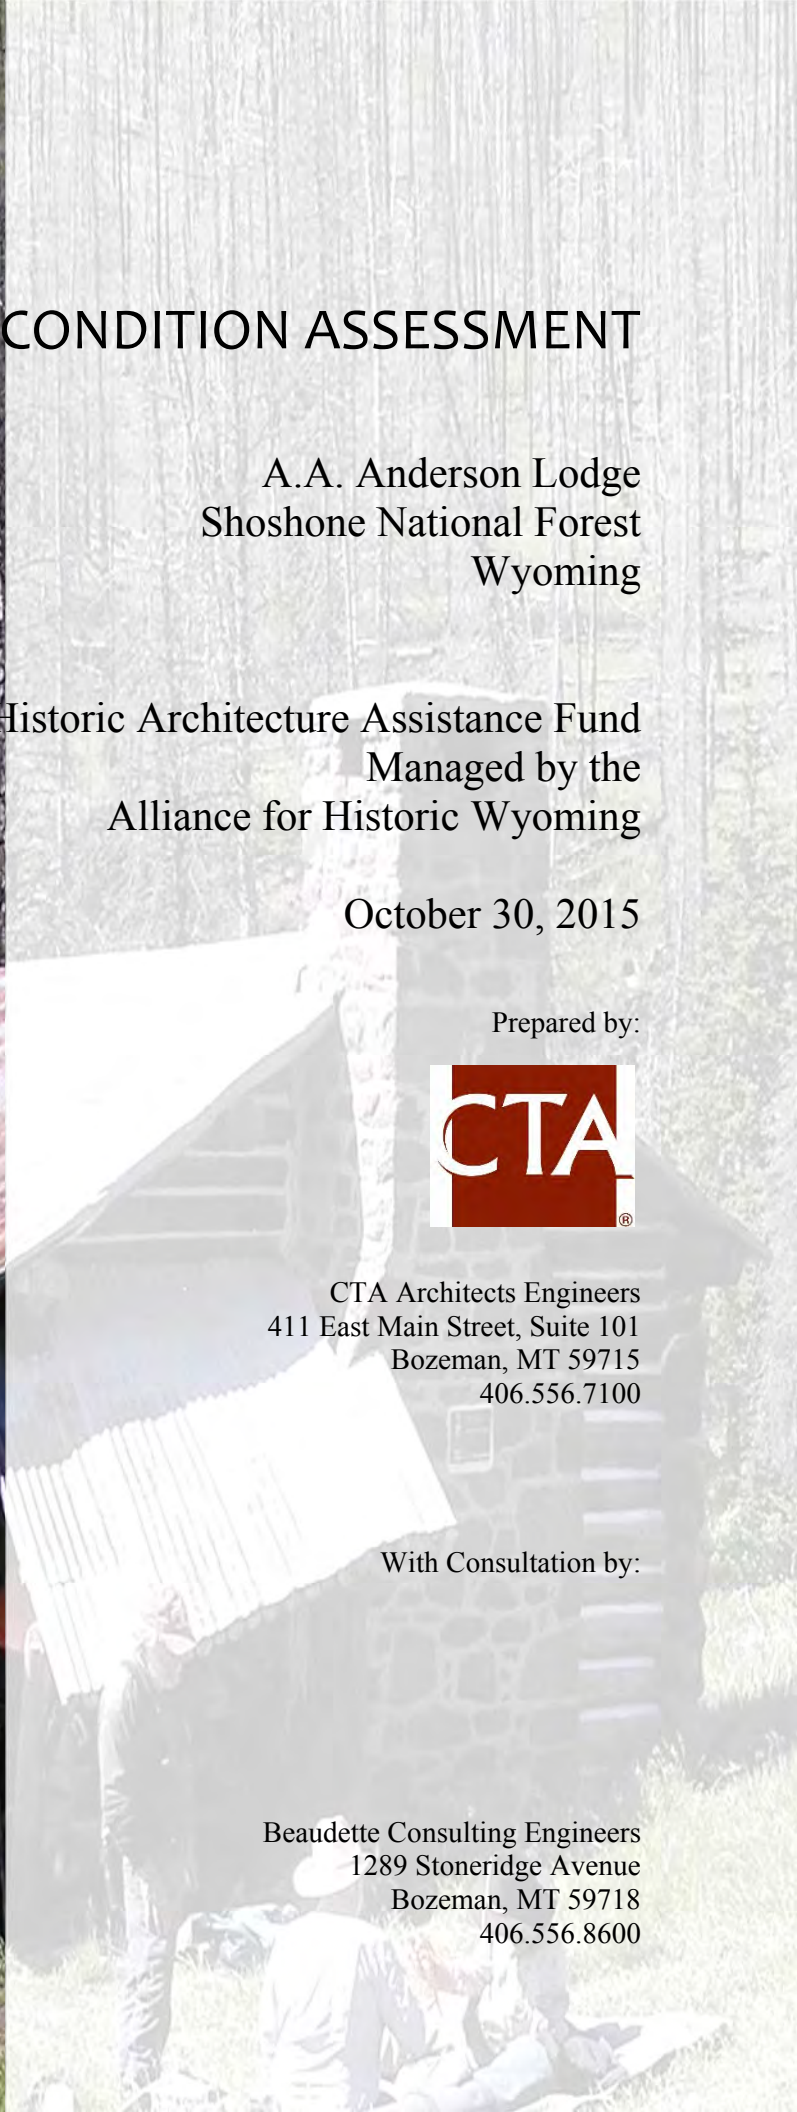
Beaudette Consulting Engineers
1289 Stoneridge Avenue
Bozeman, MT 59718
406.556.8600

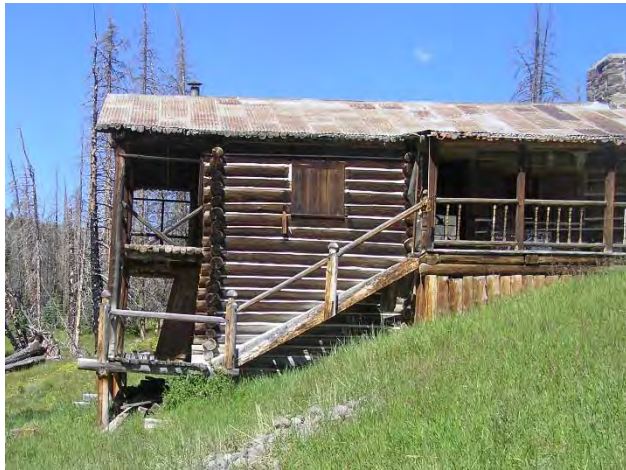
Figure 5: Anderson Lodge continues to settle to the south, as seen at the left in this photograph from the east.

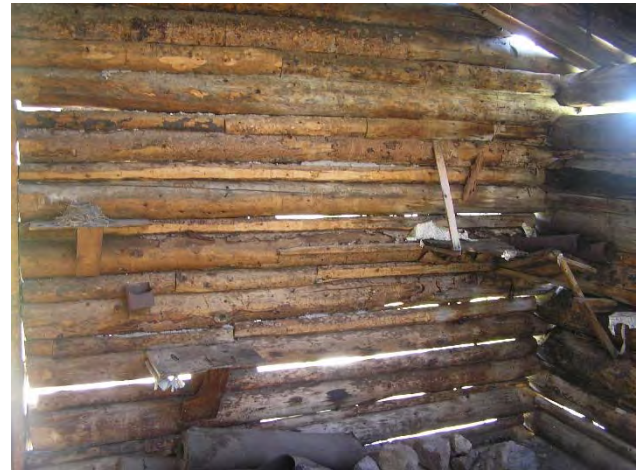
Figure 6: Erosion of daubing mortar has resulted in gaps between the Cabin's wall logs; photograph taken looking southeast.

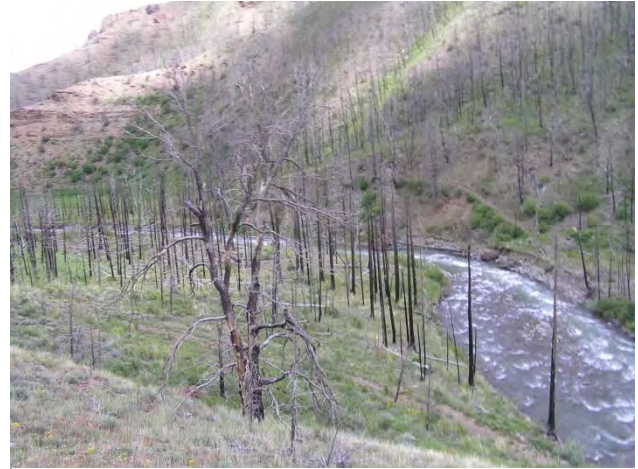
Figure 7: Greybull River in the Shoshone National Forest, as seen from pack ride leaving the Anderson Lodge site.

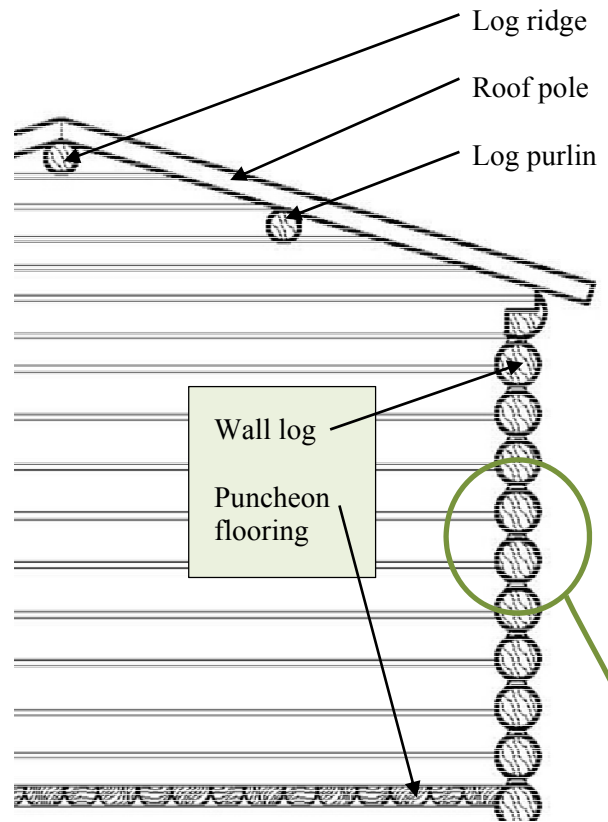
Figure 10: Partial Cross-Section of the Hired Hand's Cabin.

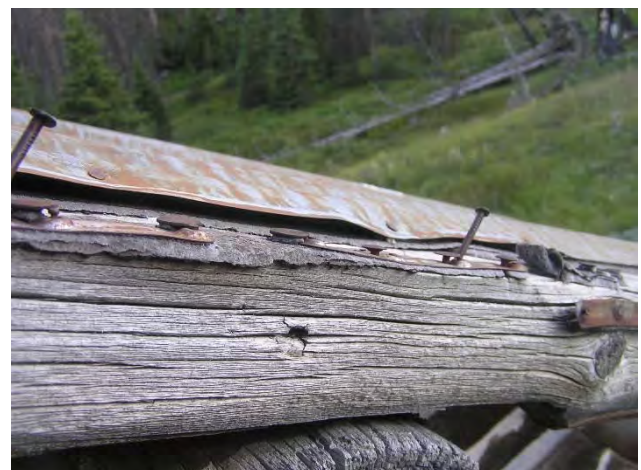
Figure 13: The roofing felt was fastened to the rake poles with metal strips that remain.

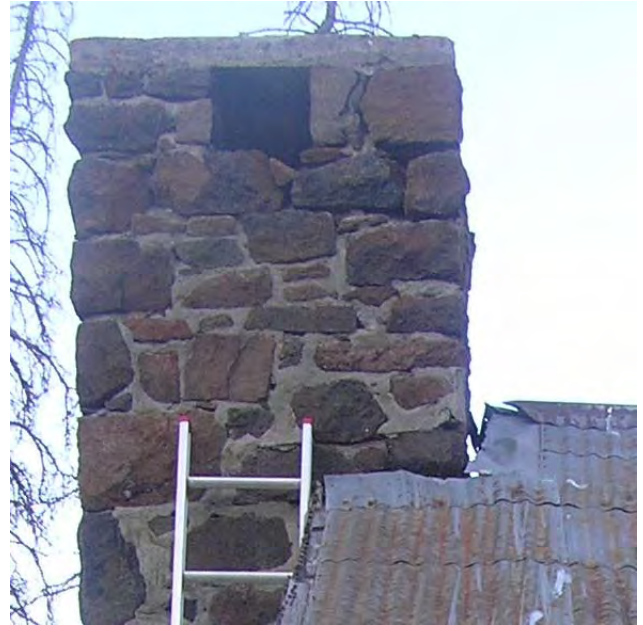
Figure 14: The building's movement away from the chimney has caused the erstwhile sheet metal flashing to fail to cover the gaps between the roofing and the chimney.

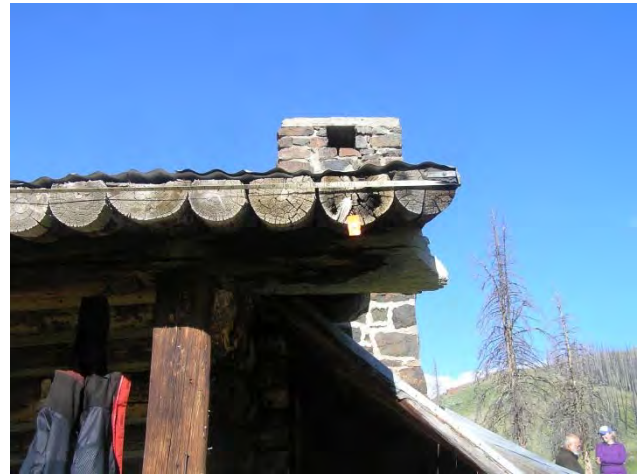
Figure 15: Deteriorated ends of roofing poles at the east porch.

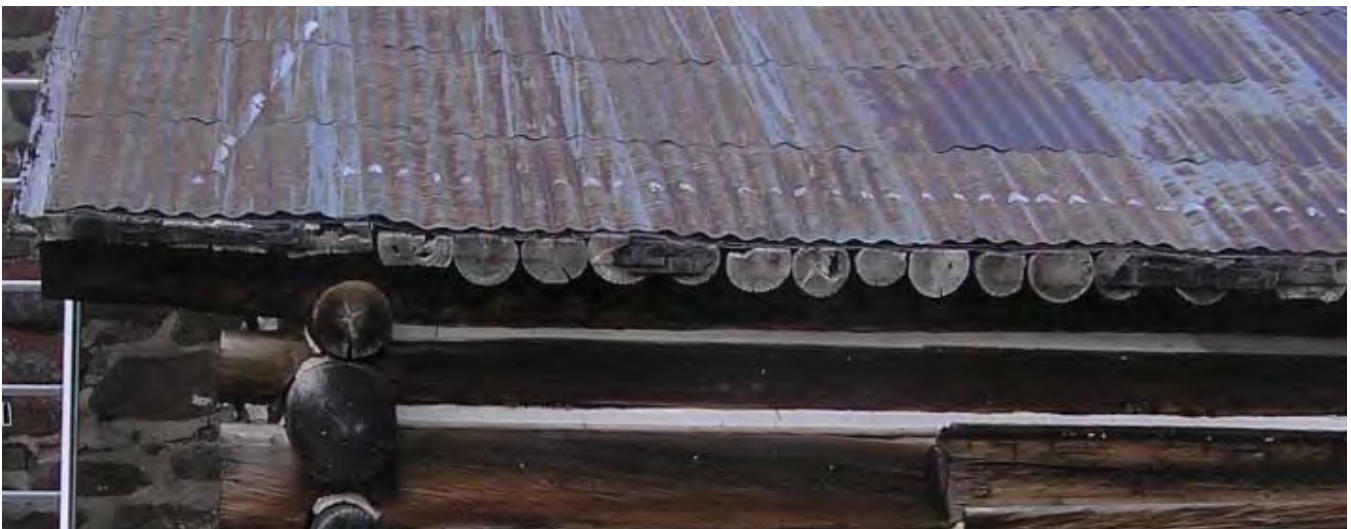
Figure 16: The roofing felt was fastened to the pole ends with a nailing strap. Much of the felt has rotten and fallen away.

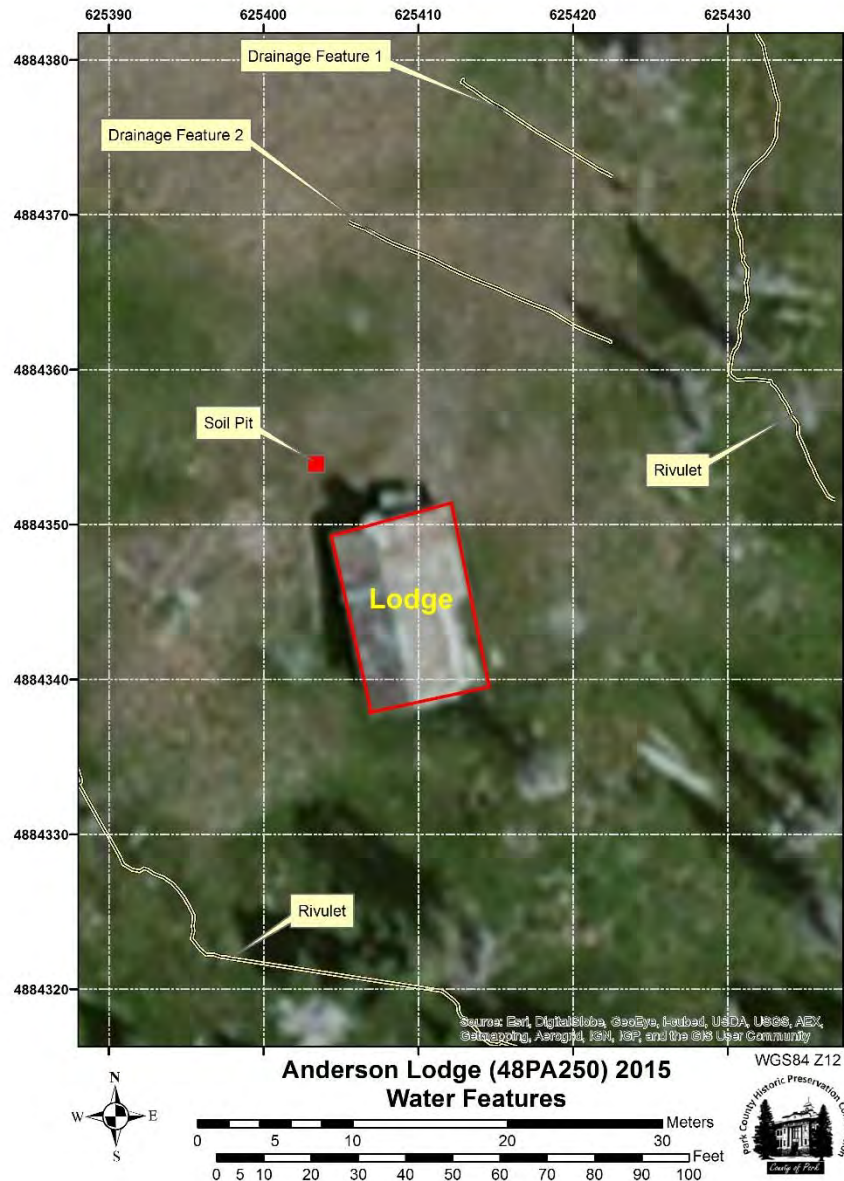
Figure 17: Excerpt from the 2015 Supplemental Documentation report, depicting the current site condition with two drainage features. Image courtesy of Lawrence Todd and Kent Houston.

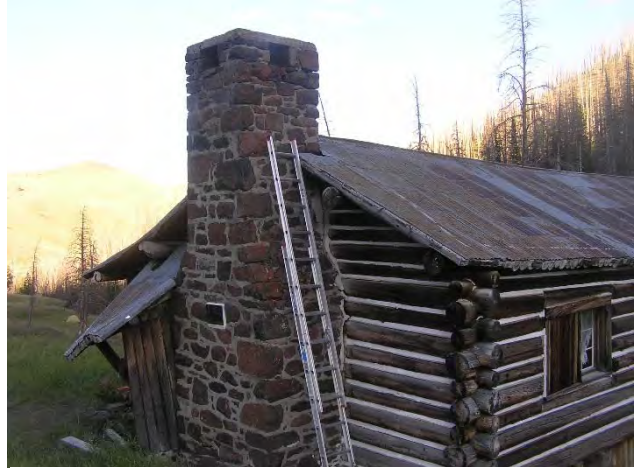
Figure 18: The stone chimney anchors down the north end of the Lodge. Photograph taken looking southeast.

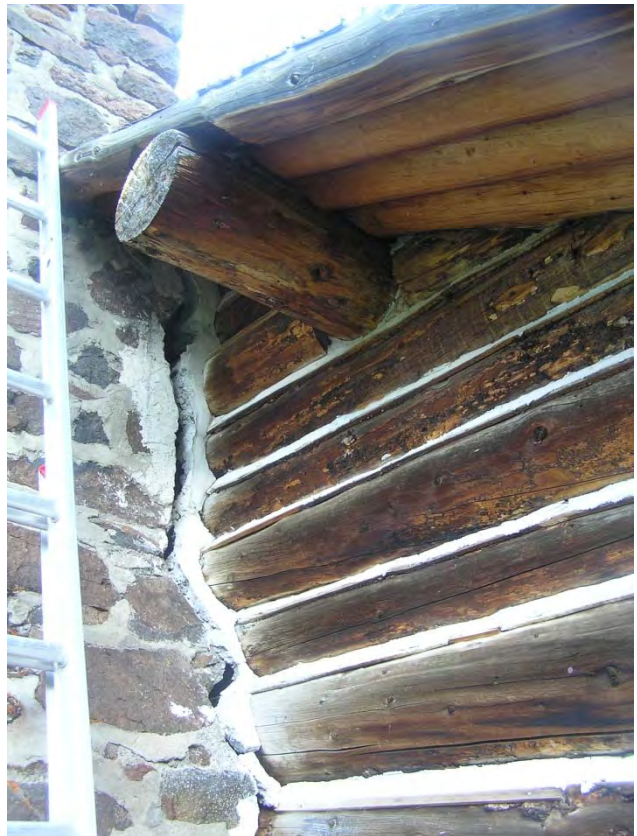
Figure 19: The building movement has caused the vertical joint between the plumb chimney and the log wall to increase over time, to as much as 2½" at the top. Note the 1993-1994 daubing mortar that filled the joint at the time.

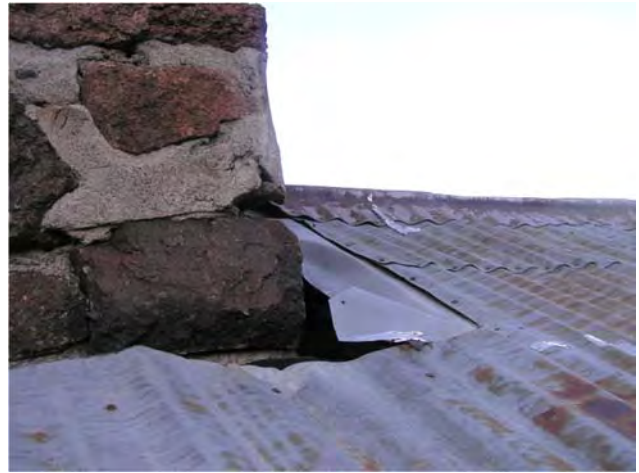
Figure 20: The sheet metal chimney flashing no longer engages the chimney.

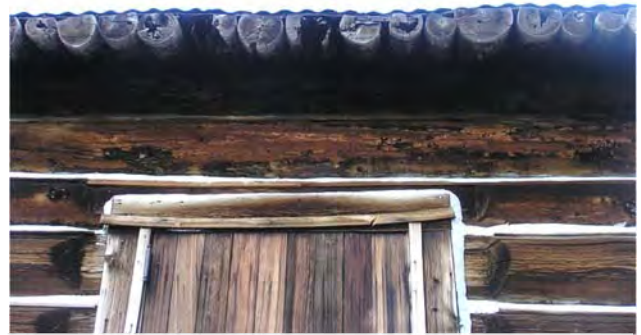
Figure 22: Daubing missing indicating natural aging & movement.

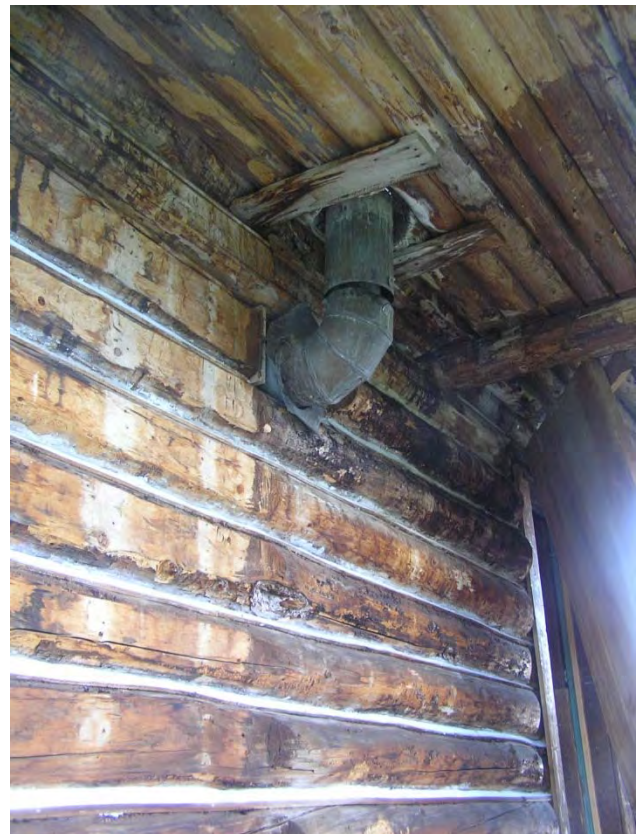
Figure 23: The daubing mortar is missing from the logs at the south wall facing the lower level porch. The wood daubing strips remain.

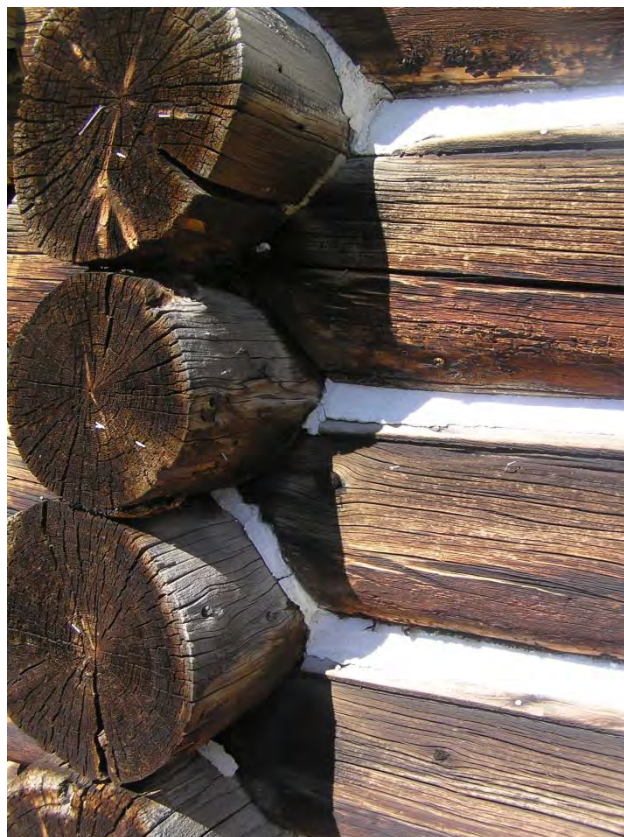
Figure 24: Building settlement has caused the daubing mortar to fail at the vertical joints of the log walls.

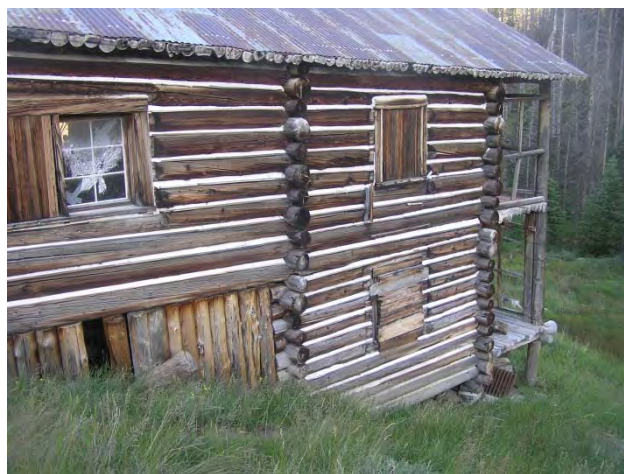
Figure 25: The stockade walls are being pulled down-slope with eroding soil.

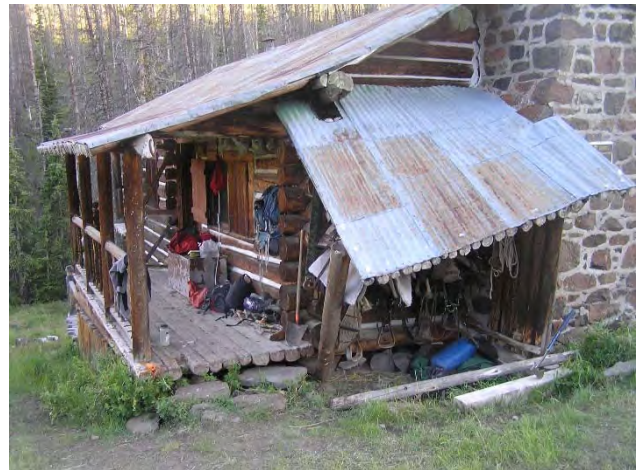
Figure 26: The east porch, as seen from the north, provides direct access to the main level Living Area.

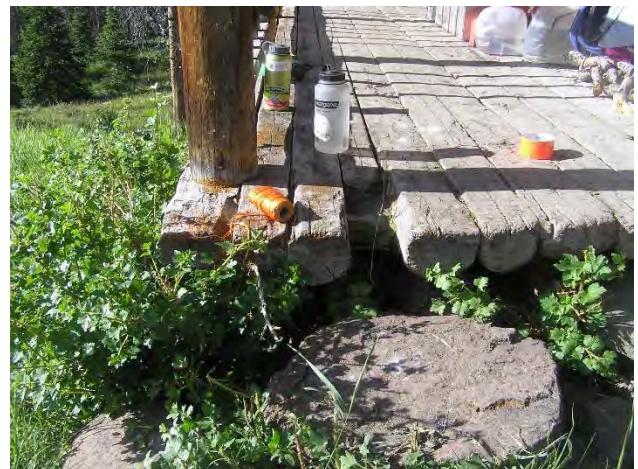
Figure 28: A 1'-4" long portion of the puncheon flooring is missing at the north end of the east porch.

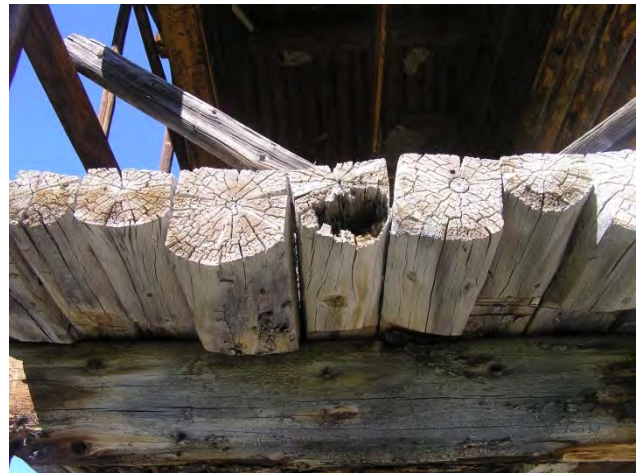
Figure 29: Rotted end of floorboard on the east end of the main level South Porch.

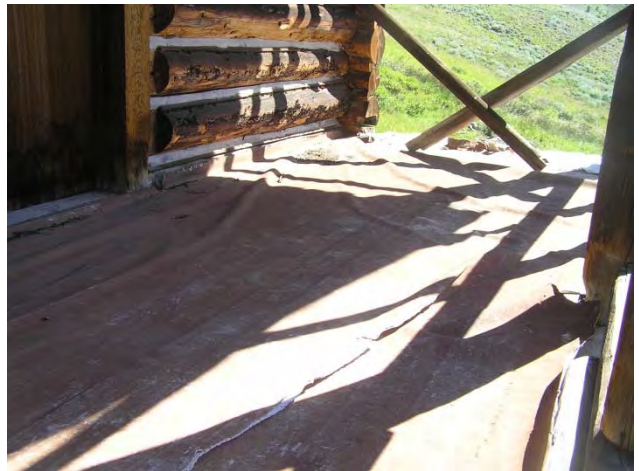
Figure 30: Painted canvas covers the puncheon flooring of the main level South Porch. It is stretched and torn.

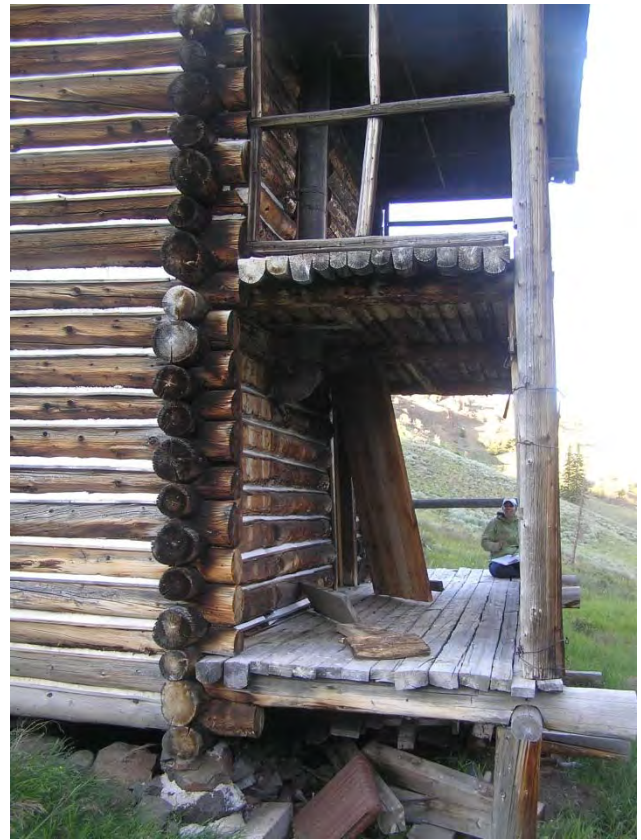
Figure 31: The lower level South Porch, as seen from the west.

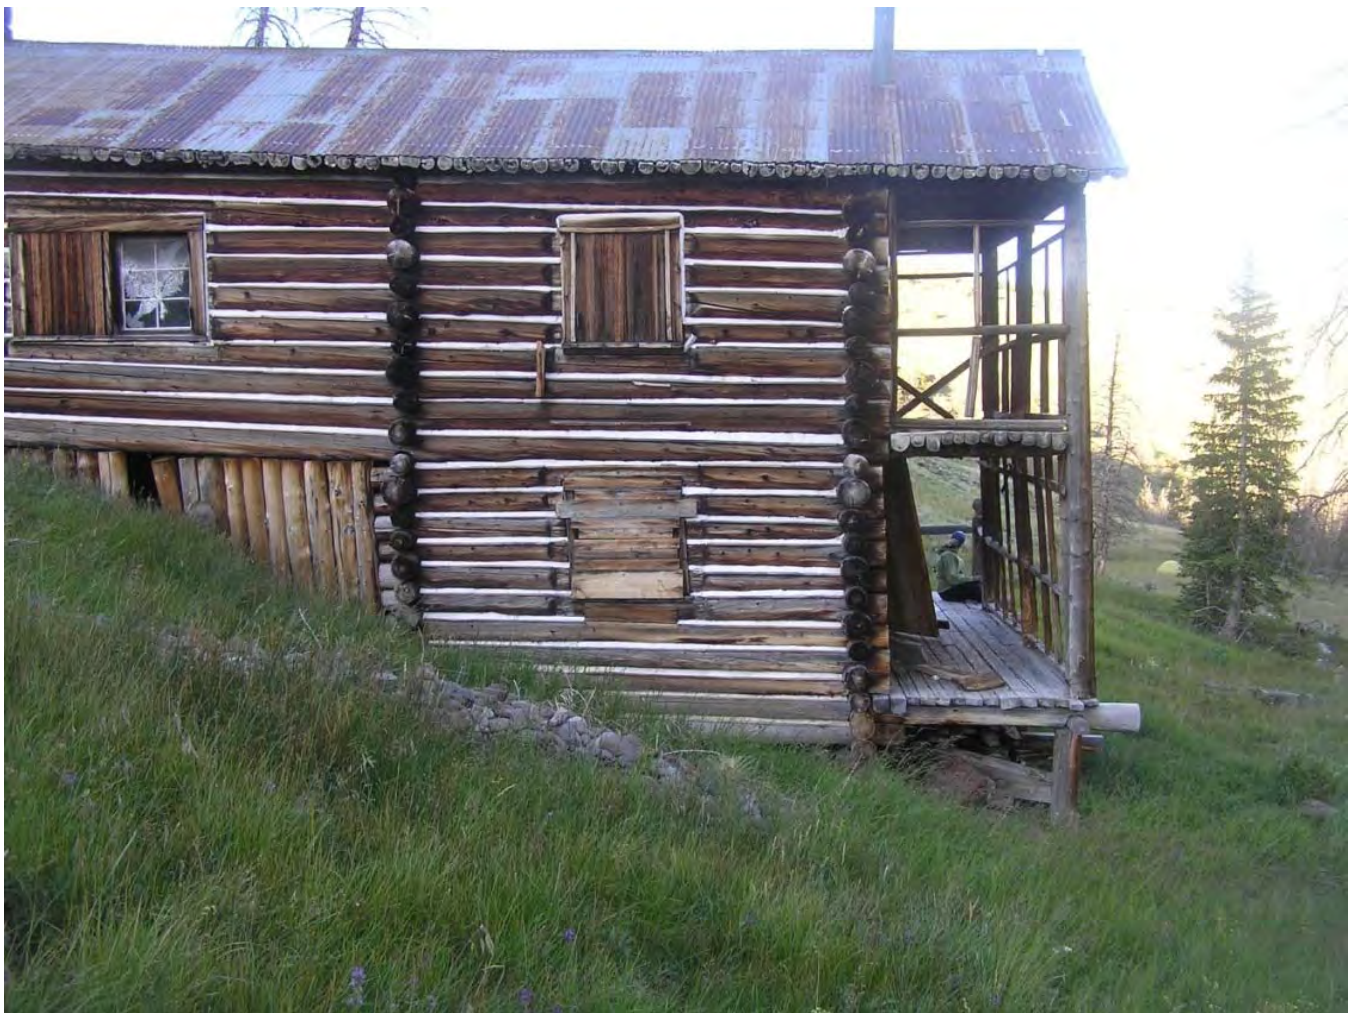
Figure 33: The windows are located on the west (as shown above) and east elevations of the Lodge.

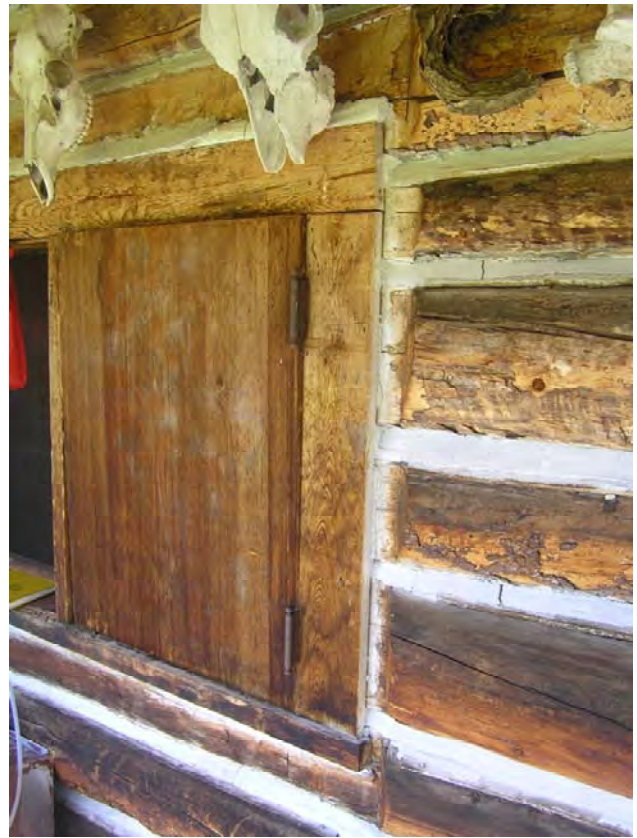
Figure 34: The typical exterior window trim is visible at the east Living Area window north of the main entry door. The typical daubing treatment around the windows (acting as a sealant to air penetration) has failed.

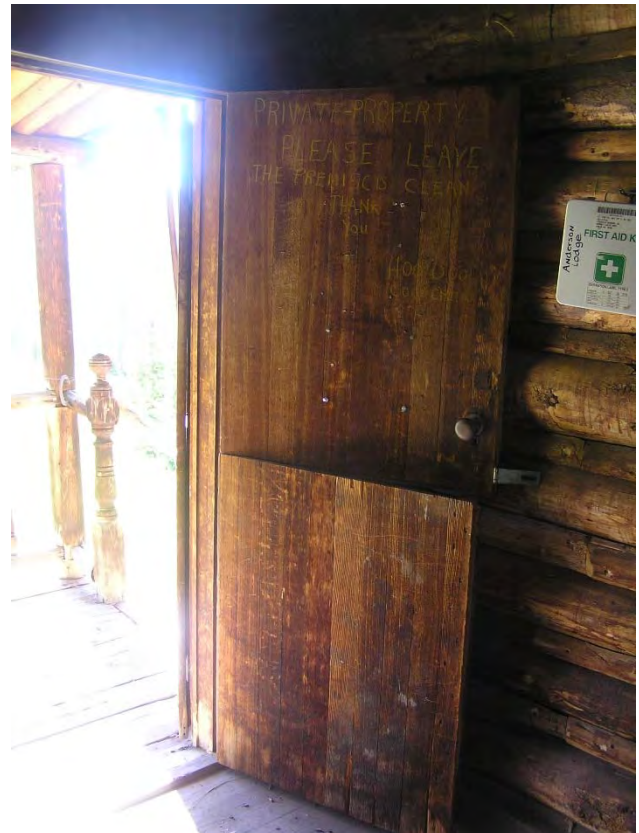
Figure 36: The exterior face of the main entry door into the Living Area, showing the sheen of the varnish on the horizontal fir boards that comprise the interior face.

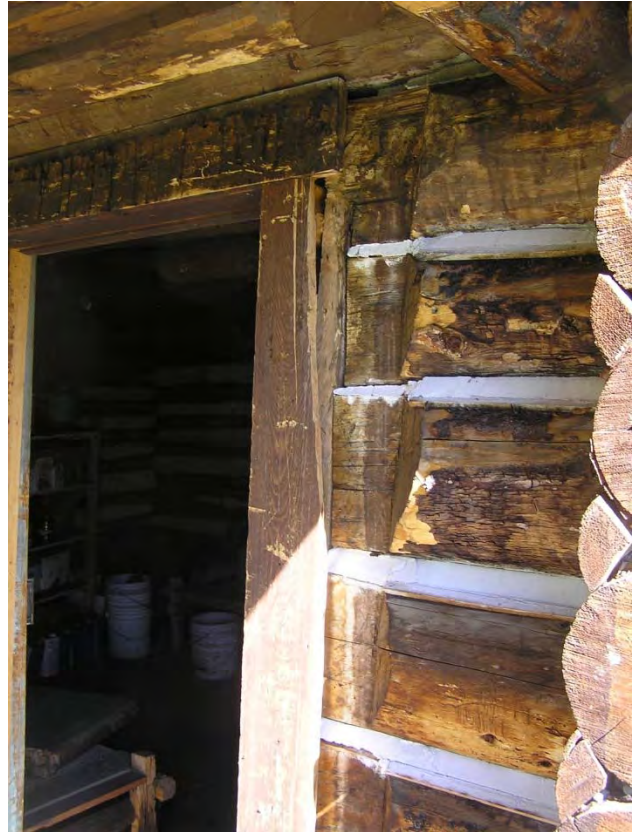
Figure 37: The jamb trim at the entry door to the lower level Kitchen has splintered off.

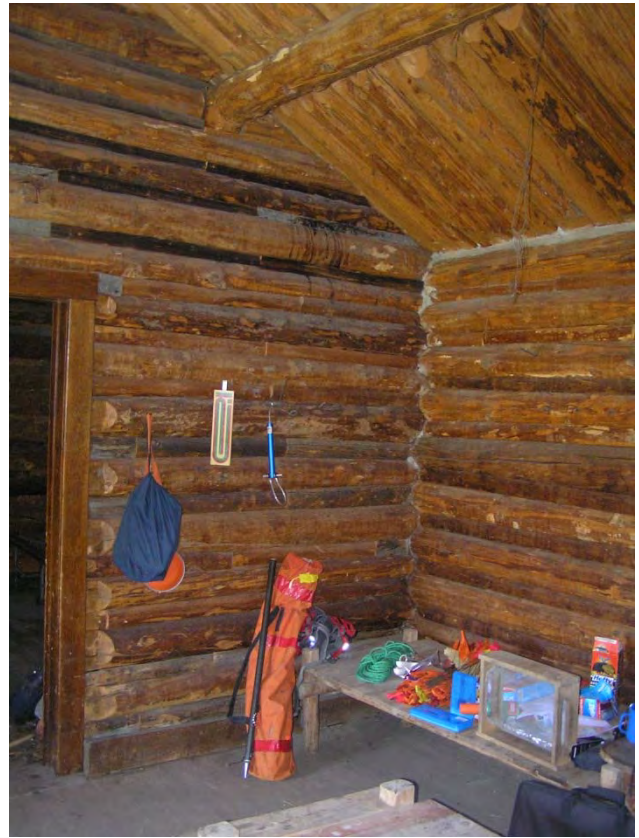
Figure 38: Exposed ridge logs & purlins.

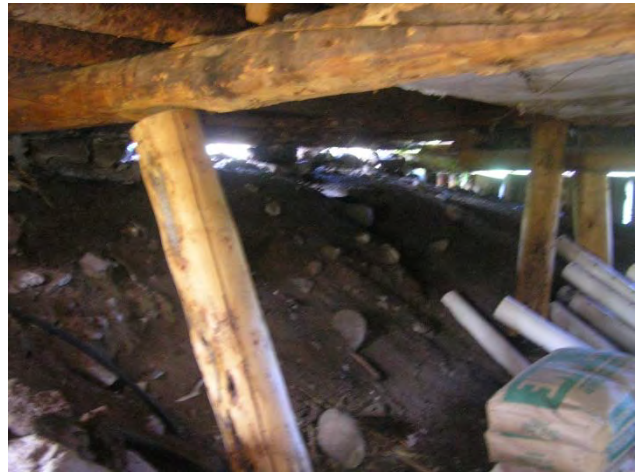
Figure 40: Plaster ceiling in crawlspace Storage Area.

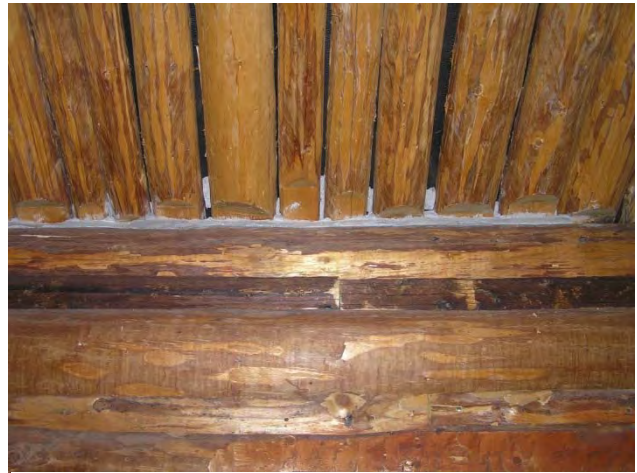
Figure 41: Chinking across the top of the Sleeping Area wall.

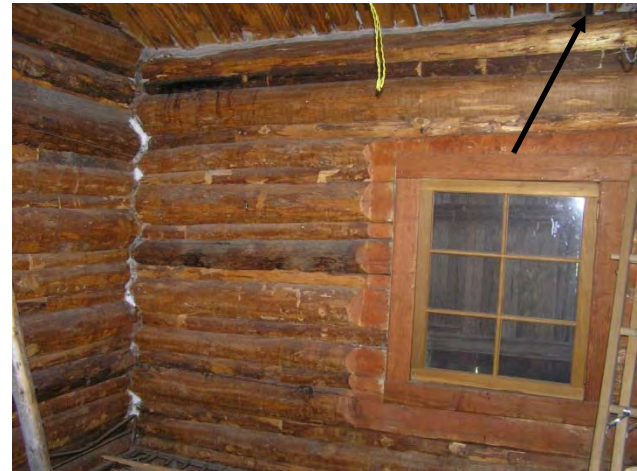
Figure 42: Dislodged vertical daubing at the southwest corner of the Sleeping Area. See also missing daubing at top of wall, designated by the arrow tip.

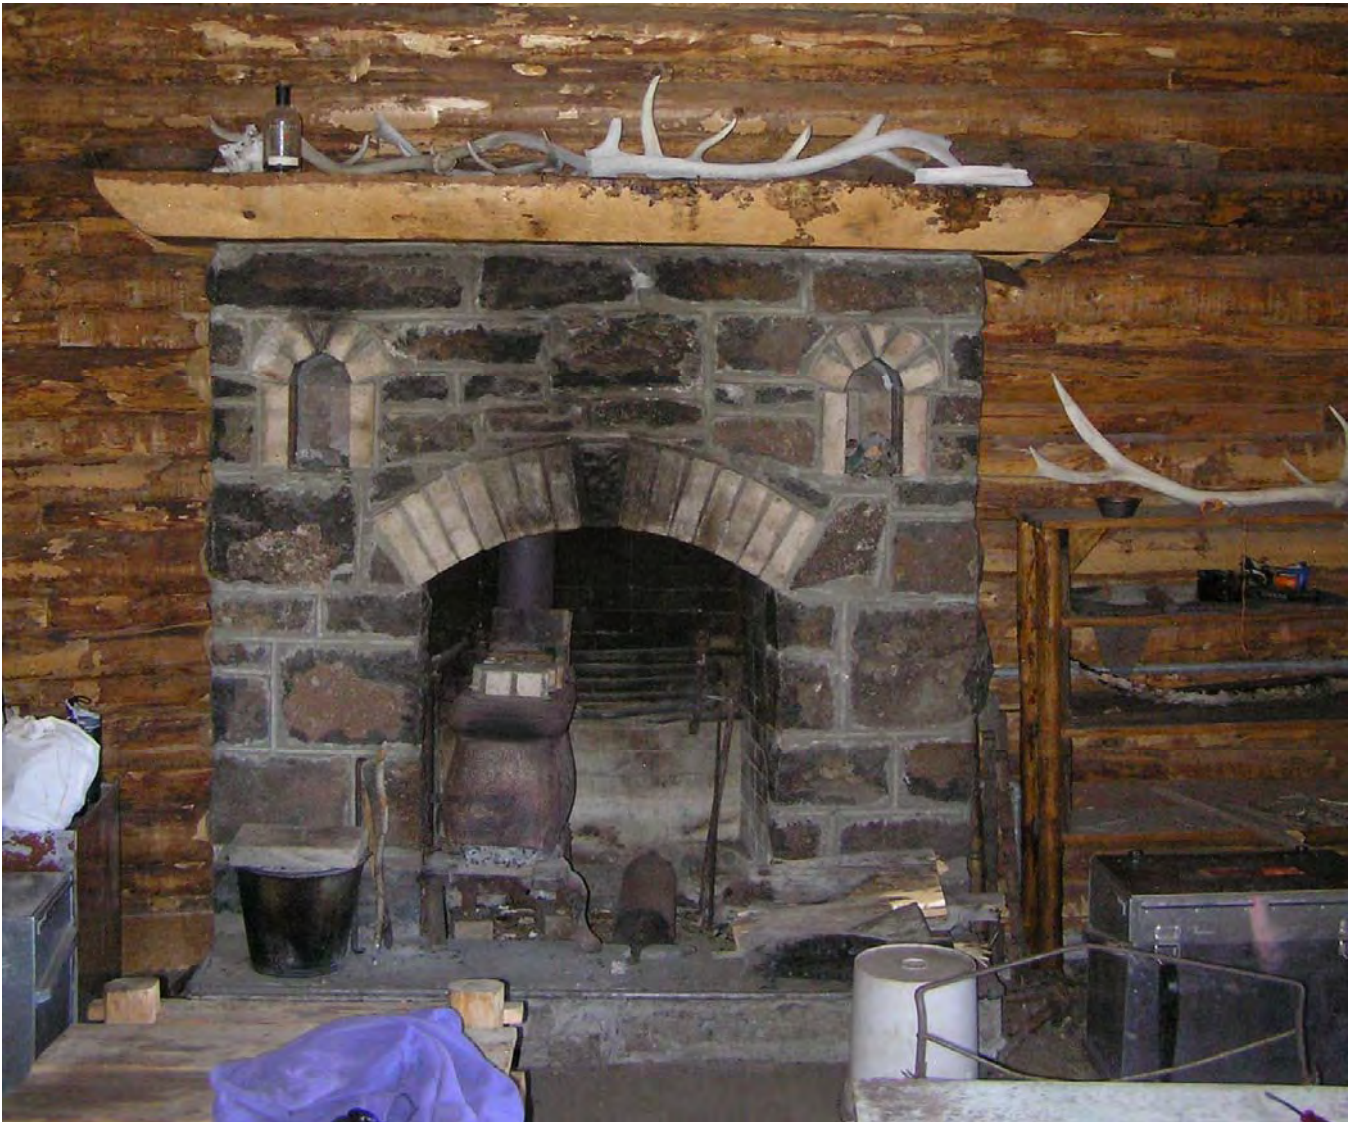
Figure 43: The fireplace has a commanding presence at the north end of the Living Area.

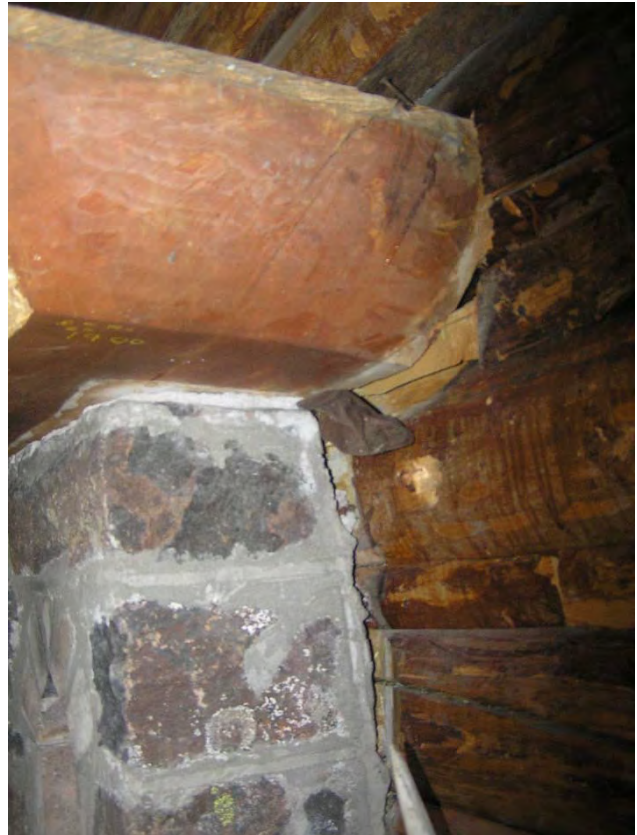
Figure 44: The stone surround of the fireplace has separated from the log wall.

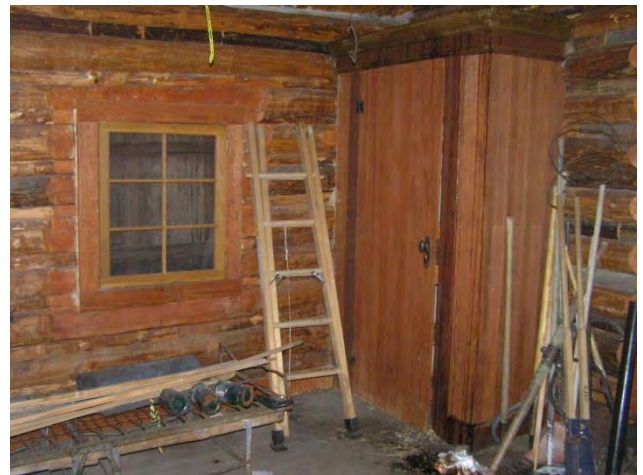
Figure 46: The wooden wardrobe in the northwest corner of the Sleeping Area.

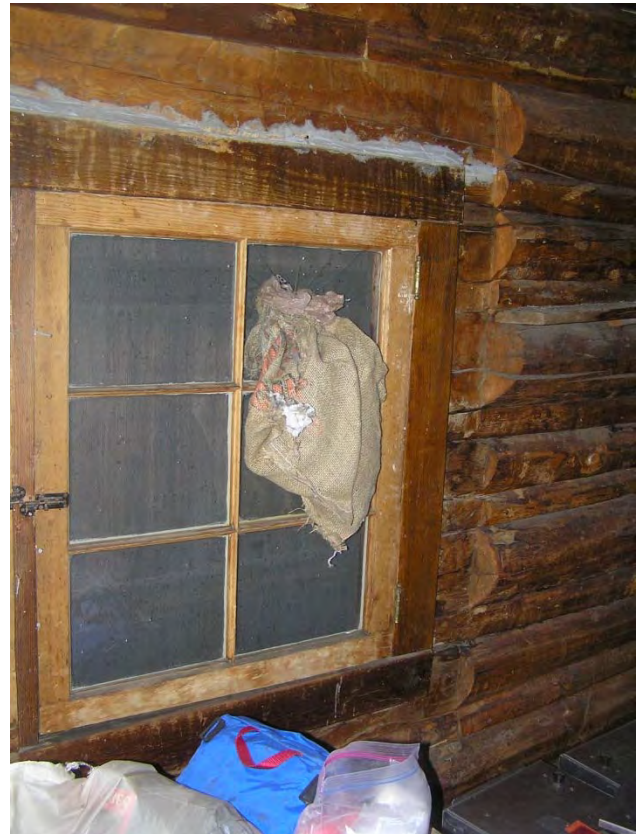
Figure 48: The logs have been beveled and planed to provide a straight substrate for the window trim.

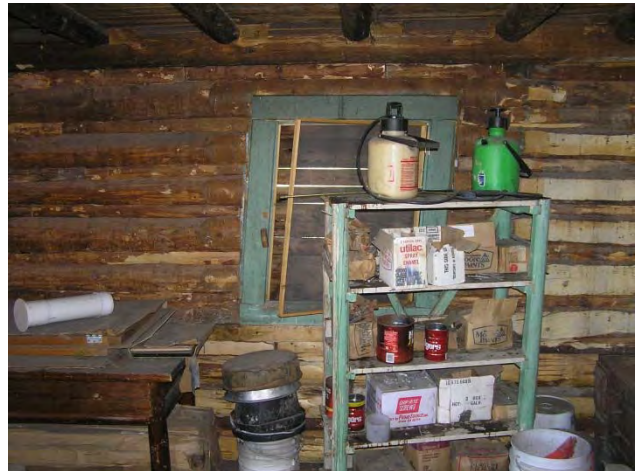
Figure 49: The window opening at the west wall of the Kitchen Area is substantially racked. The daubing that sealed the window joints has failed and fallen, due to building settlement.

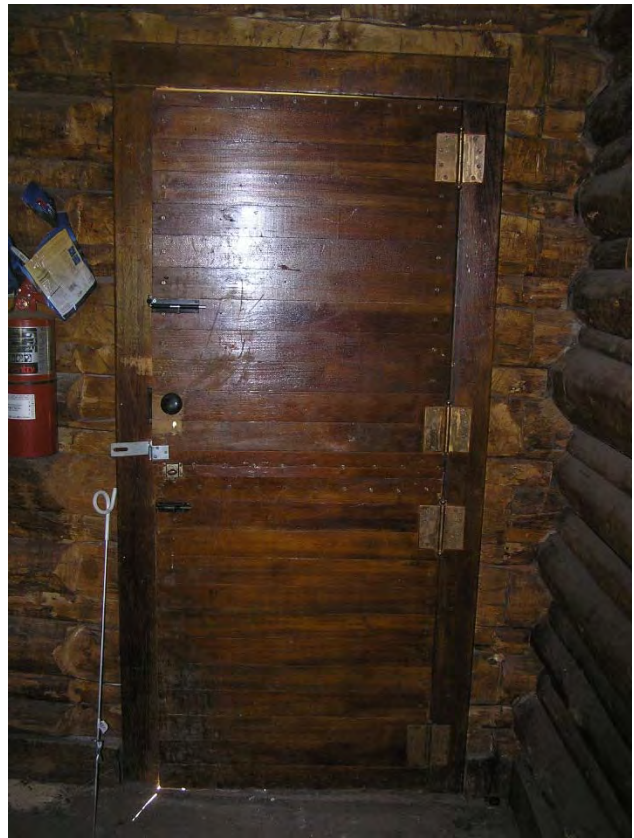
Figure 50: The interior face of the entry door to the Living Area shows the sheen used in the finish on the horizontal boards of both leaves of the Dutch door.

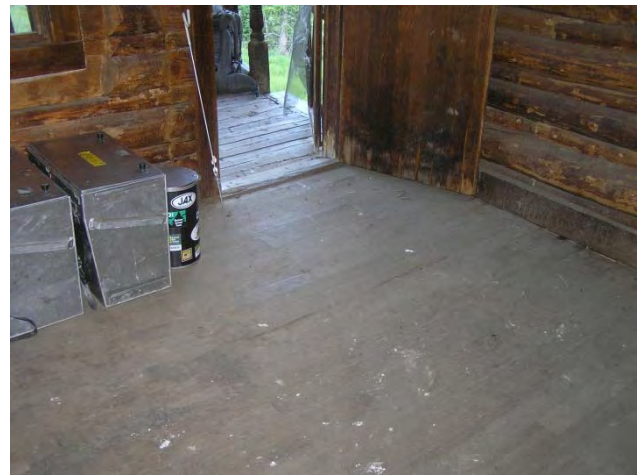
Figure 52: The main level rooms have a simple wood baseboard, as seen on the south wall of the Living Area (looking southeast towards the entry door).

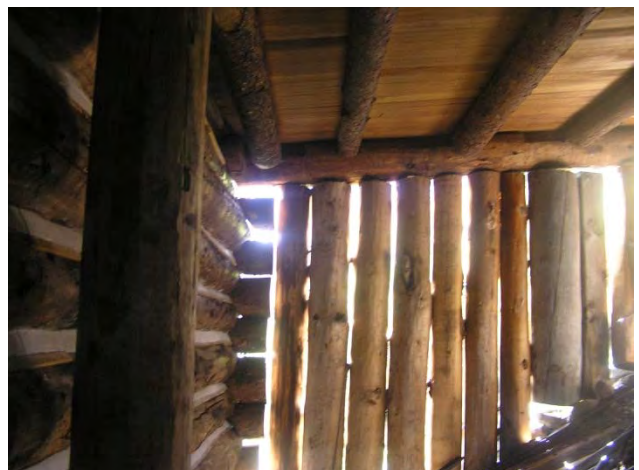
Figure 54: Living Area flooring from crawlspace below.

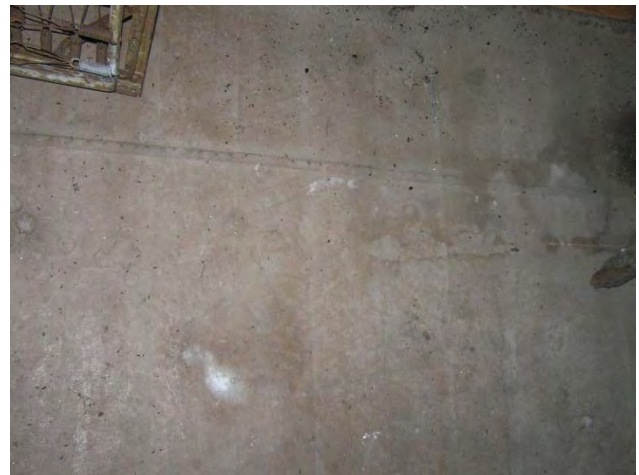
Figure 55: The wood flooring boards telegraph through the sheet linoleum in the Sleeping Area.

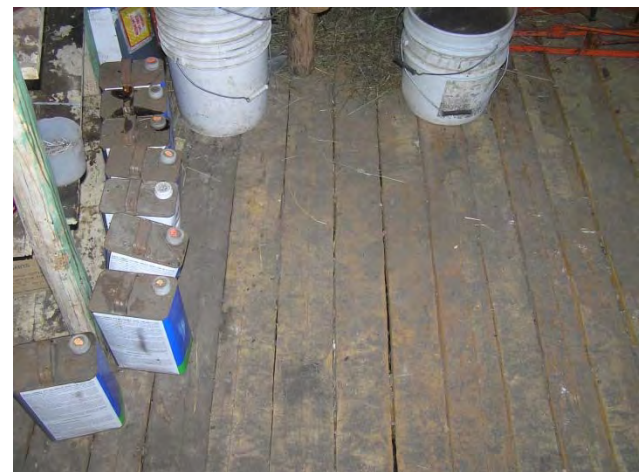
Figure 56: The puncheon flooring in the Kitchen Area and the adjacent Screen Porch was replaced in 1993-1994.

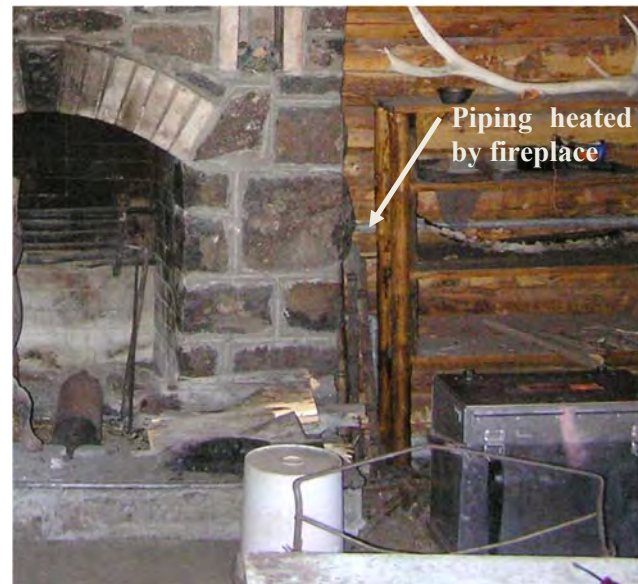
Figure 58: Warmth from the fireplace heated water in the piping shown at the arrow tip. This piping then wends its way to the top of the east wall and over to the tank in the adjacent Sleeping Area, shown above.
