A.A. ANDERSON LODGE CONDITION ASSESSMENT

A.A. Anderson Lodge
Shoshone National Forest
Wyoming

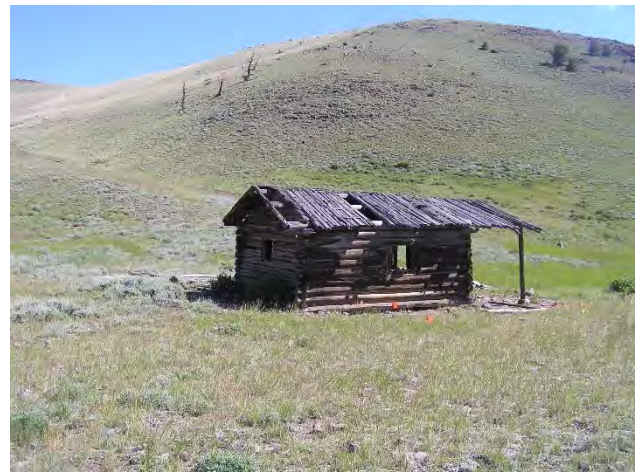
Figure 59: View, towards the northeast, of the Cabin, upon approach from the Anderson Lodge.

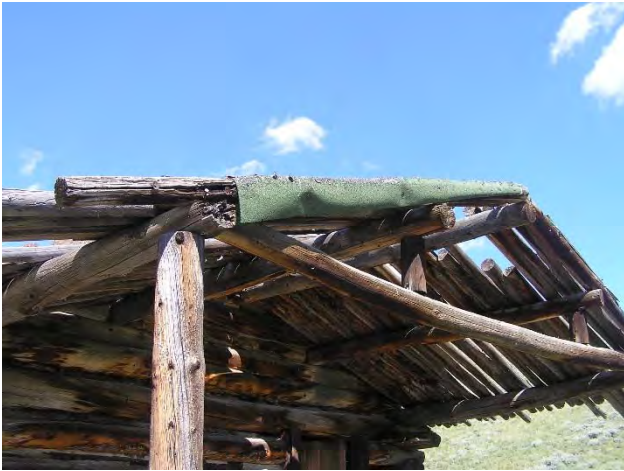
Figure 62: The roofing was pulled over the rake logs, as depicted on this south log of the entry porch.

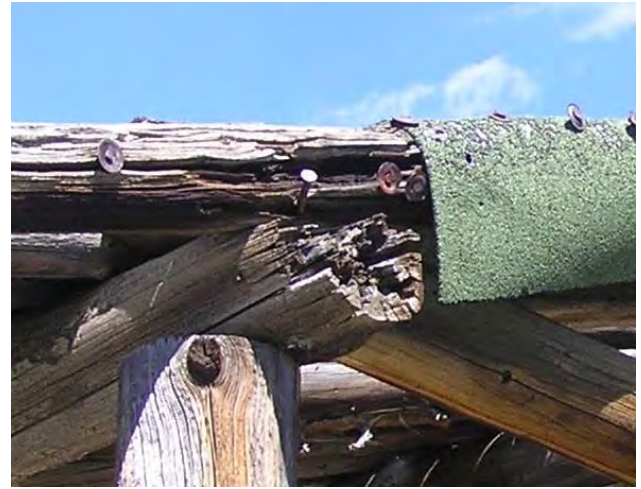
Figure 65: The rake logs and porch beams are rotted from moisture penetration.

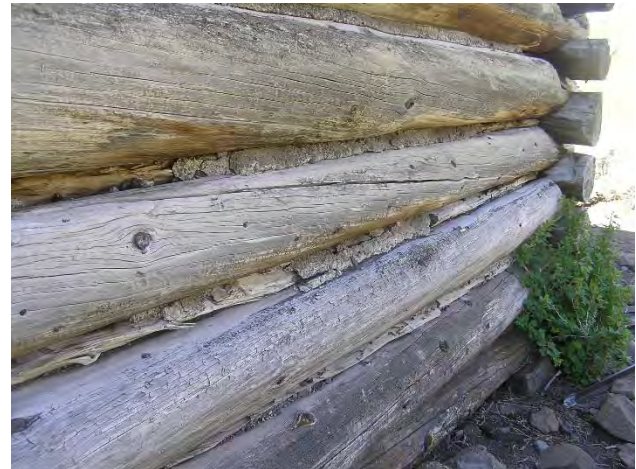
Figure 66: Very little of the original daubing mortar remains in the log walls.

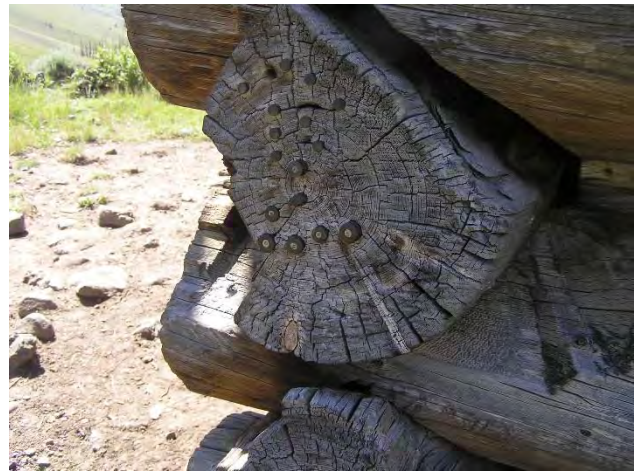
Figure 69: Bullet shells dated 1890 decorate one of the log ends.

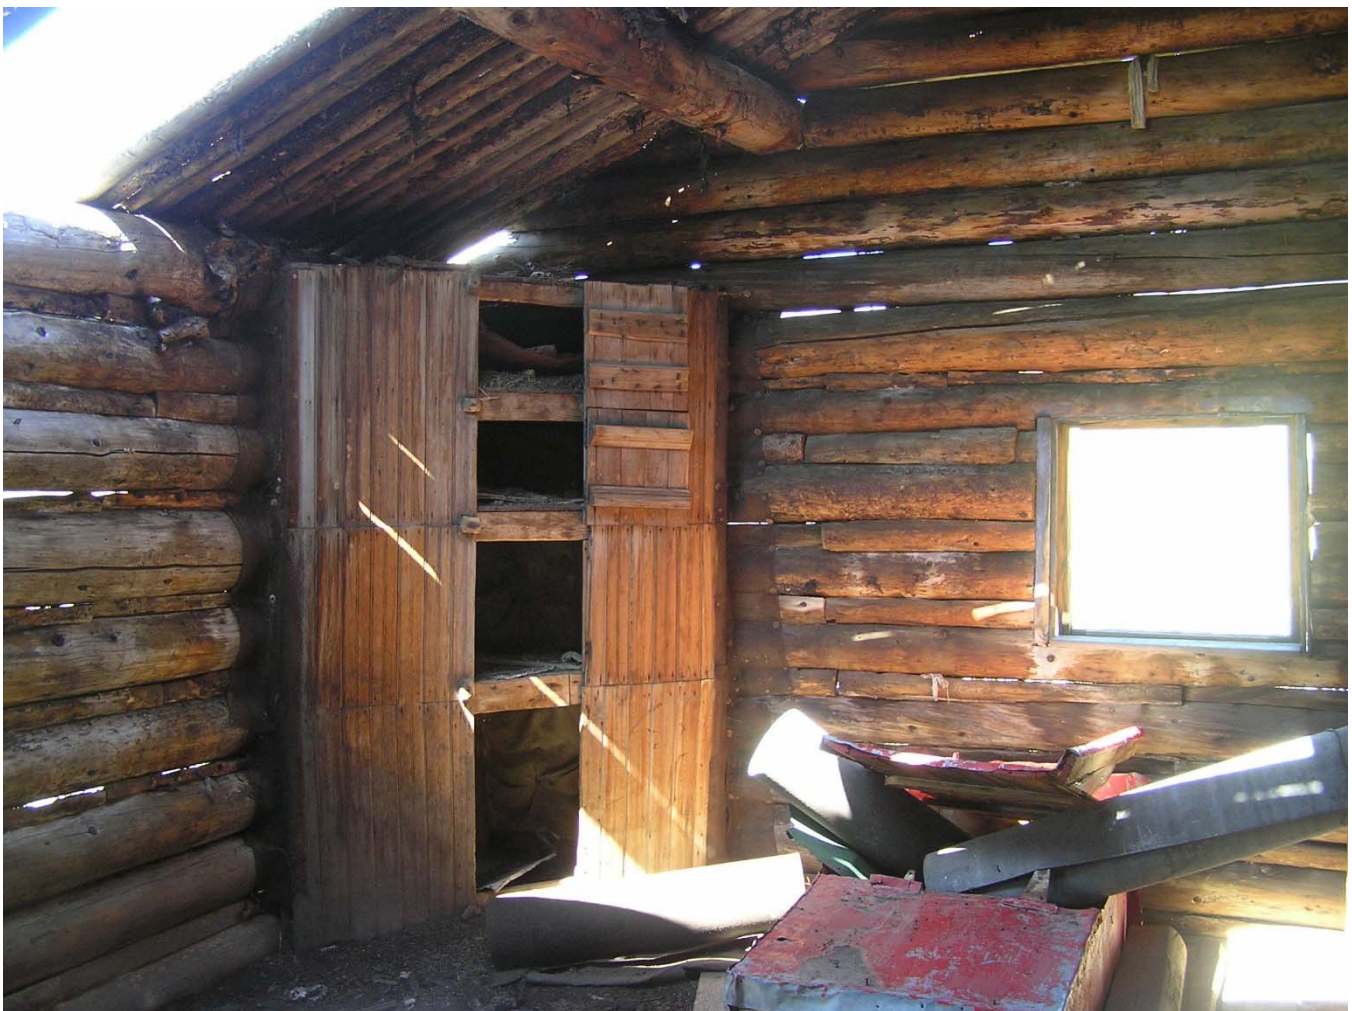
Figure 75: The Cabin interior was fitted with a wardrobe, for protective storage, in the southwest corner.

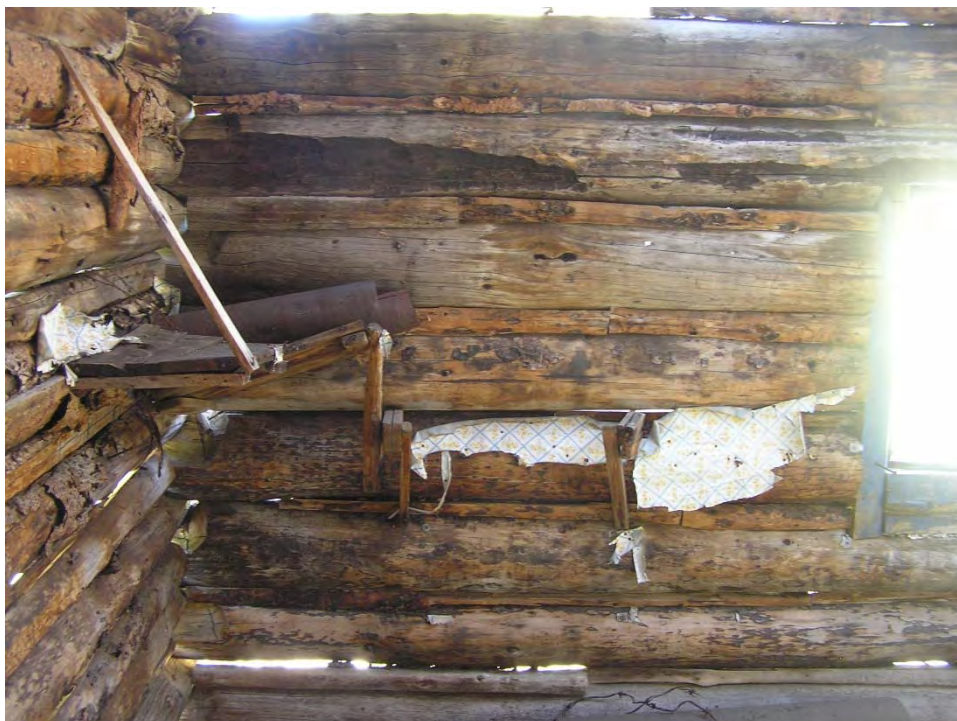
Figure 76: Wallpaper or shelf paper remnants remain in the southeast corner of the Cabin.

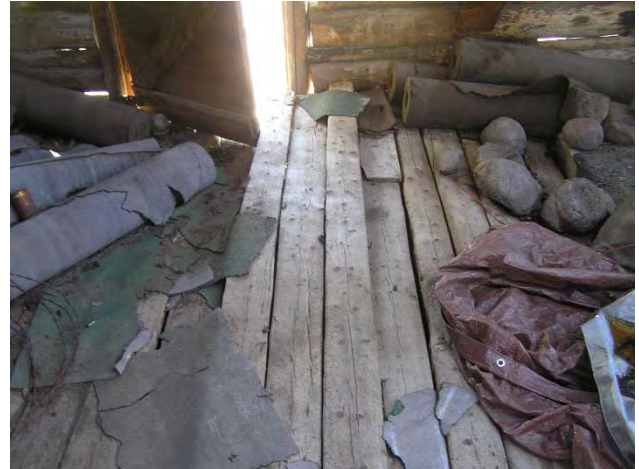
Figure 78: Looking east towards the floor boards that have popped up near the entry.

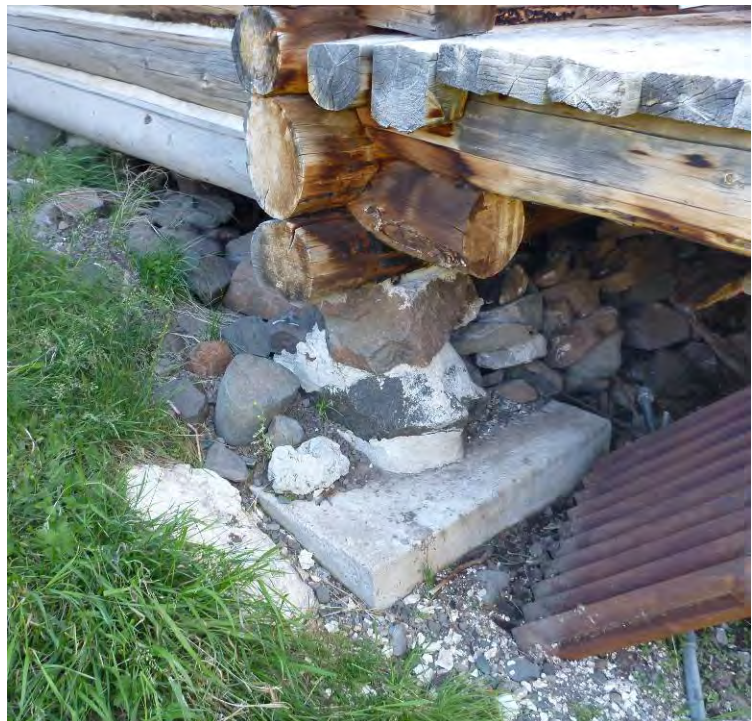
Figure 6: This rubble stone pier is located at the southwest corner of the kitchen and is supported by a concrete pad constructed during the 1991 repairs.

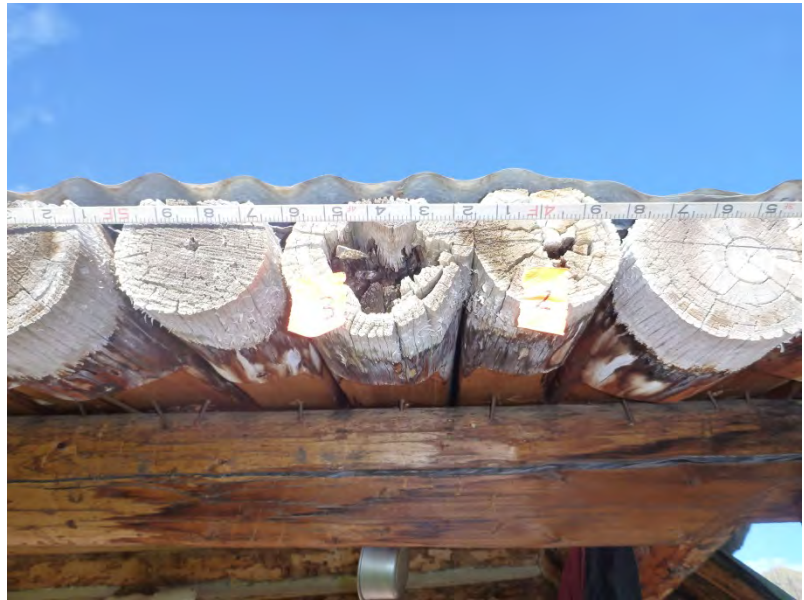
Figure 7: Deteriorated log rafter tail (pole) ends at the east porch.

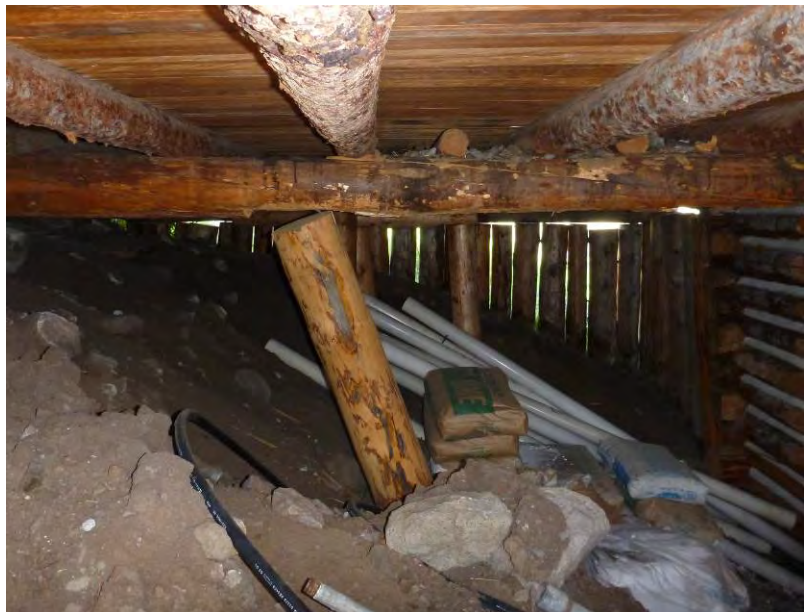
Figure 8: Displaced log column in crawl space below the living room floor framing. Erosion in the crawl space has dislodged the column base from the footing element.

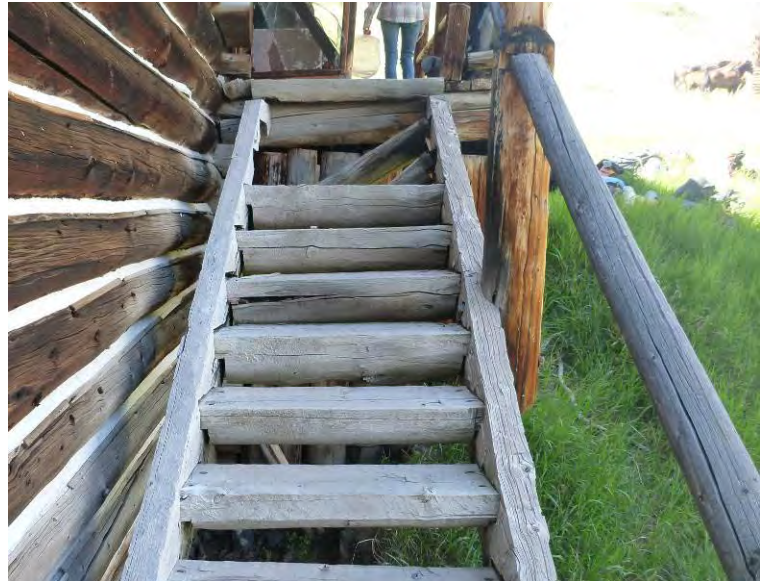
Figure 9: The 1991 stair is exposed to the elements. Logs are deteriorated and spiked connections have failed.

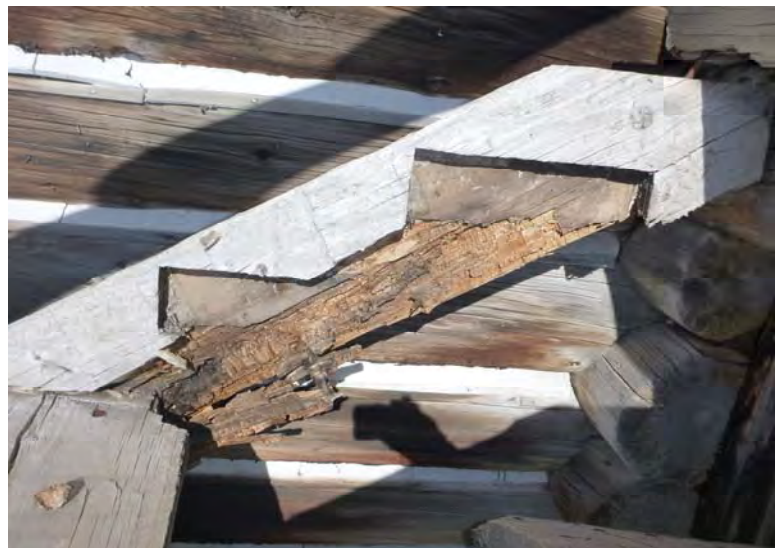
Figure 10: Failed connection of the tread logs to the stringer due to rot.

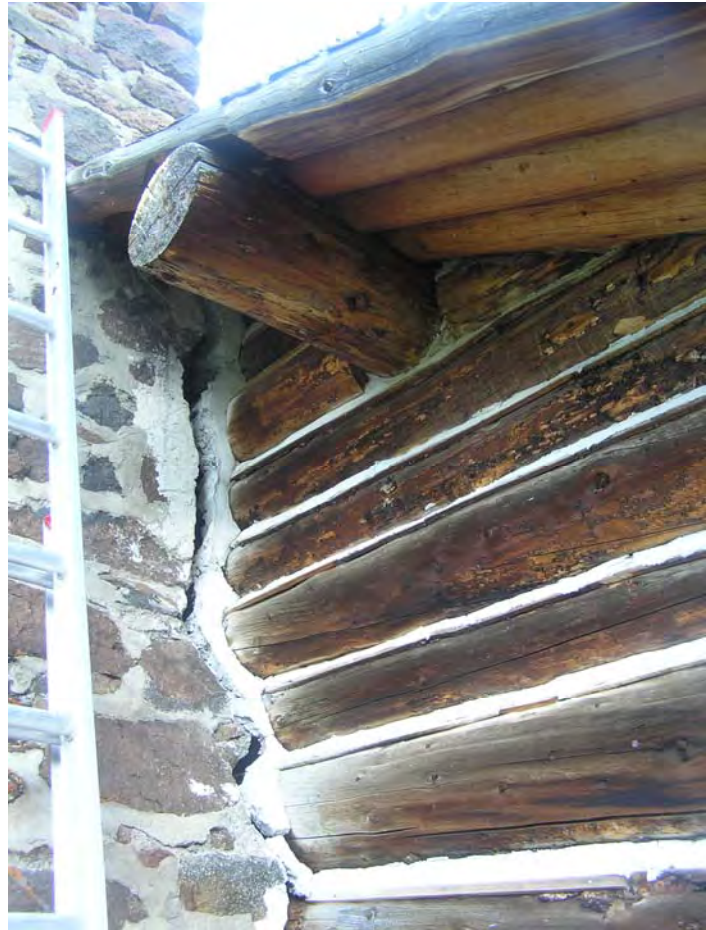
Figure 11: Gap at stone chimney and north log wall.

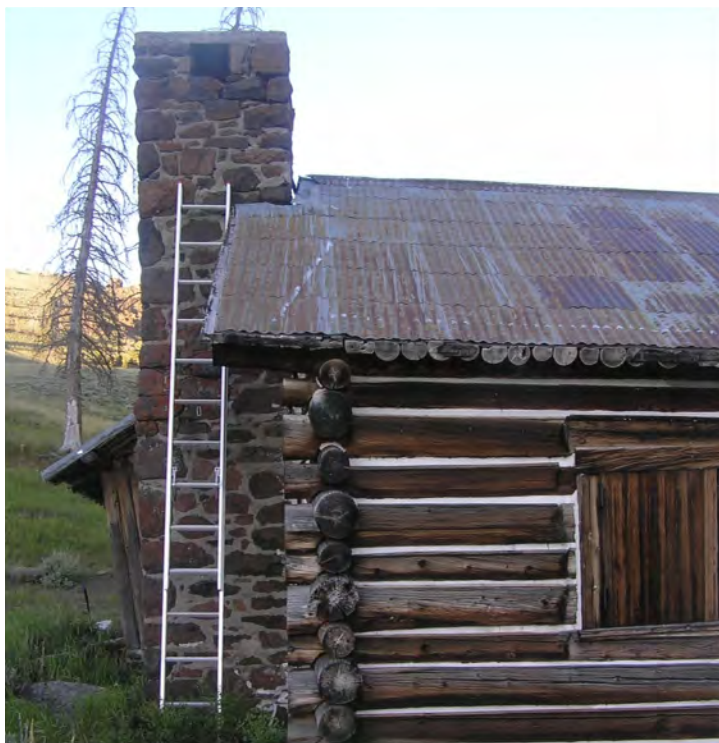
Figure 12: Stone chimney as seen looking east.

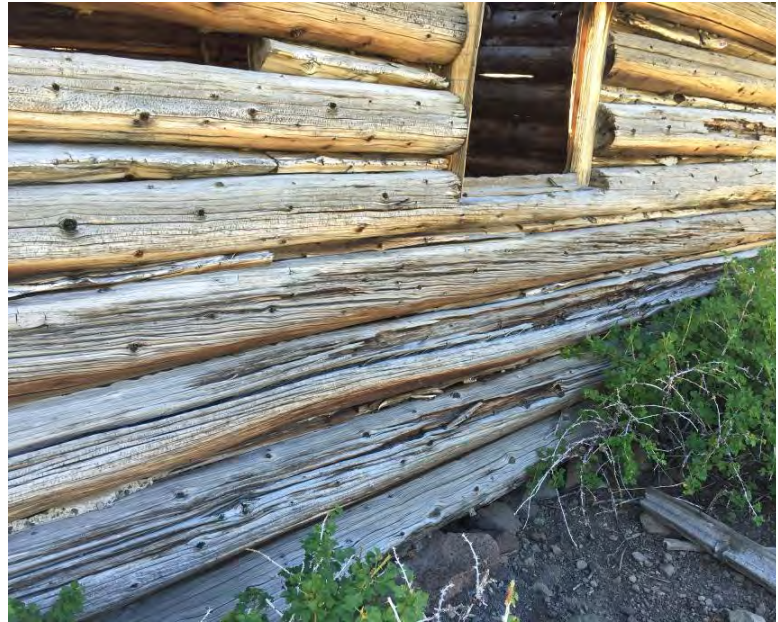
Figure 14: The wall logs at the west elevation are deteriorated and should be replaced.

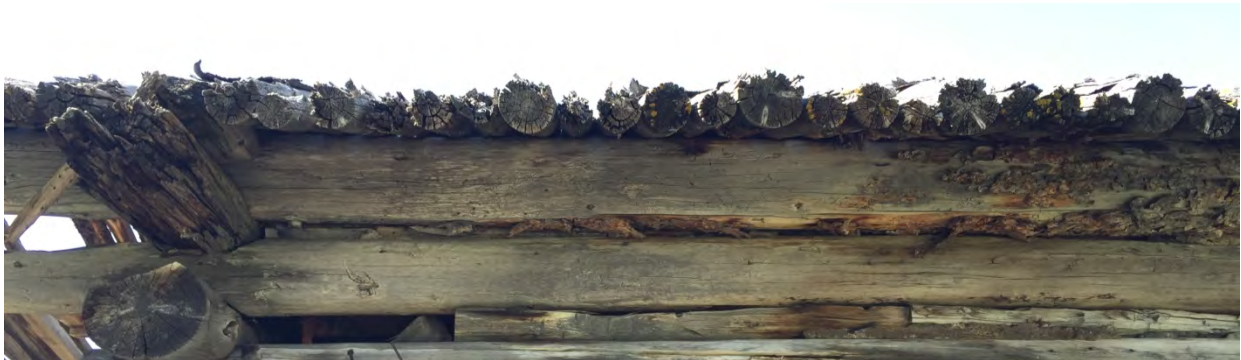
Figure 15: Roof poles at the overhangs are severely deteriorated.

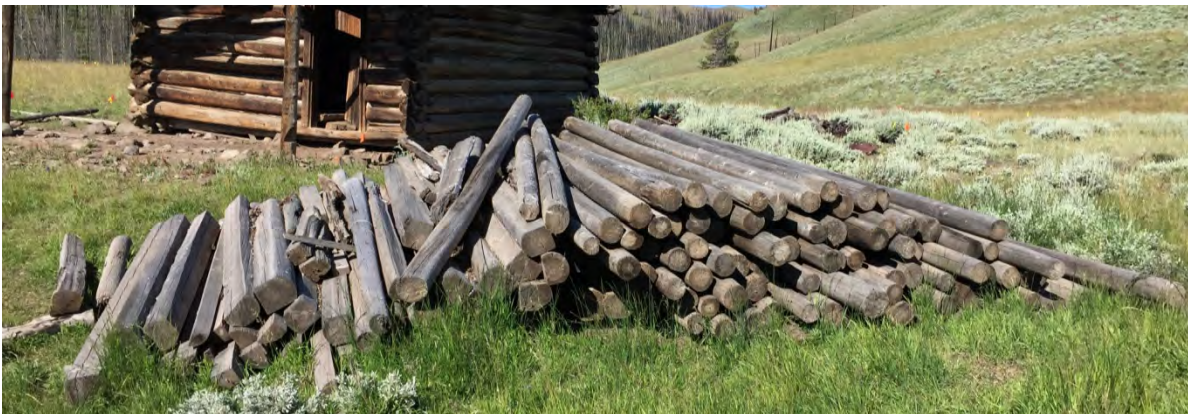
Figure 16: Small diameter logs were brought to the site during the 1991 repair work.

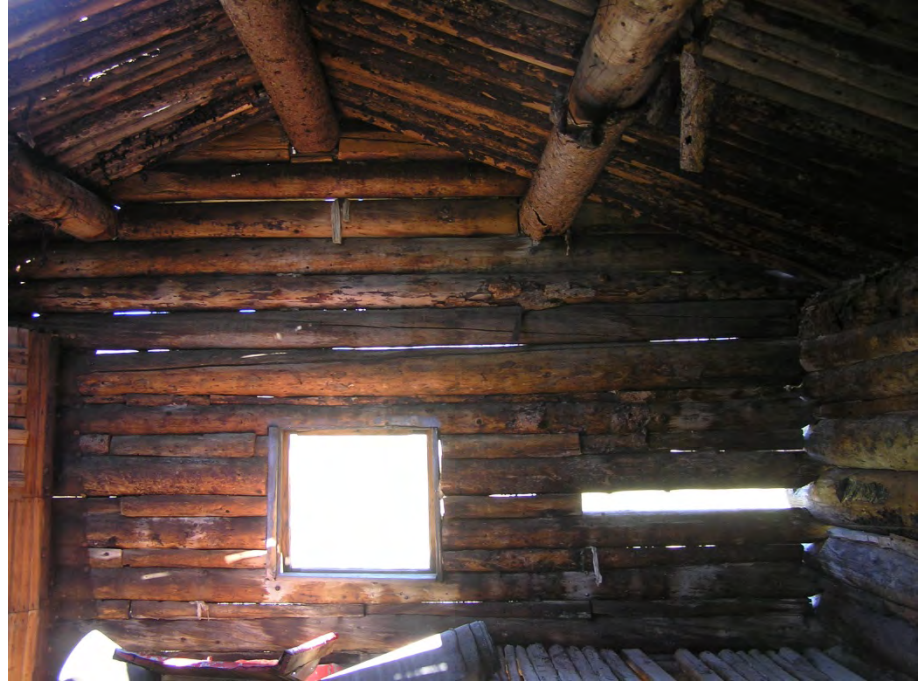
Figure 17: Cabin interior as seen from the west entrance.

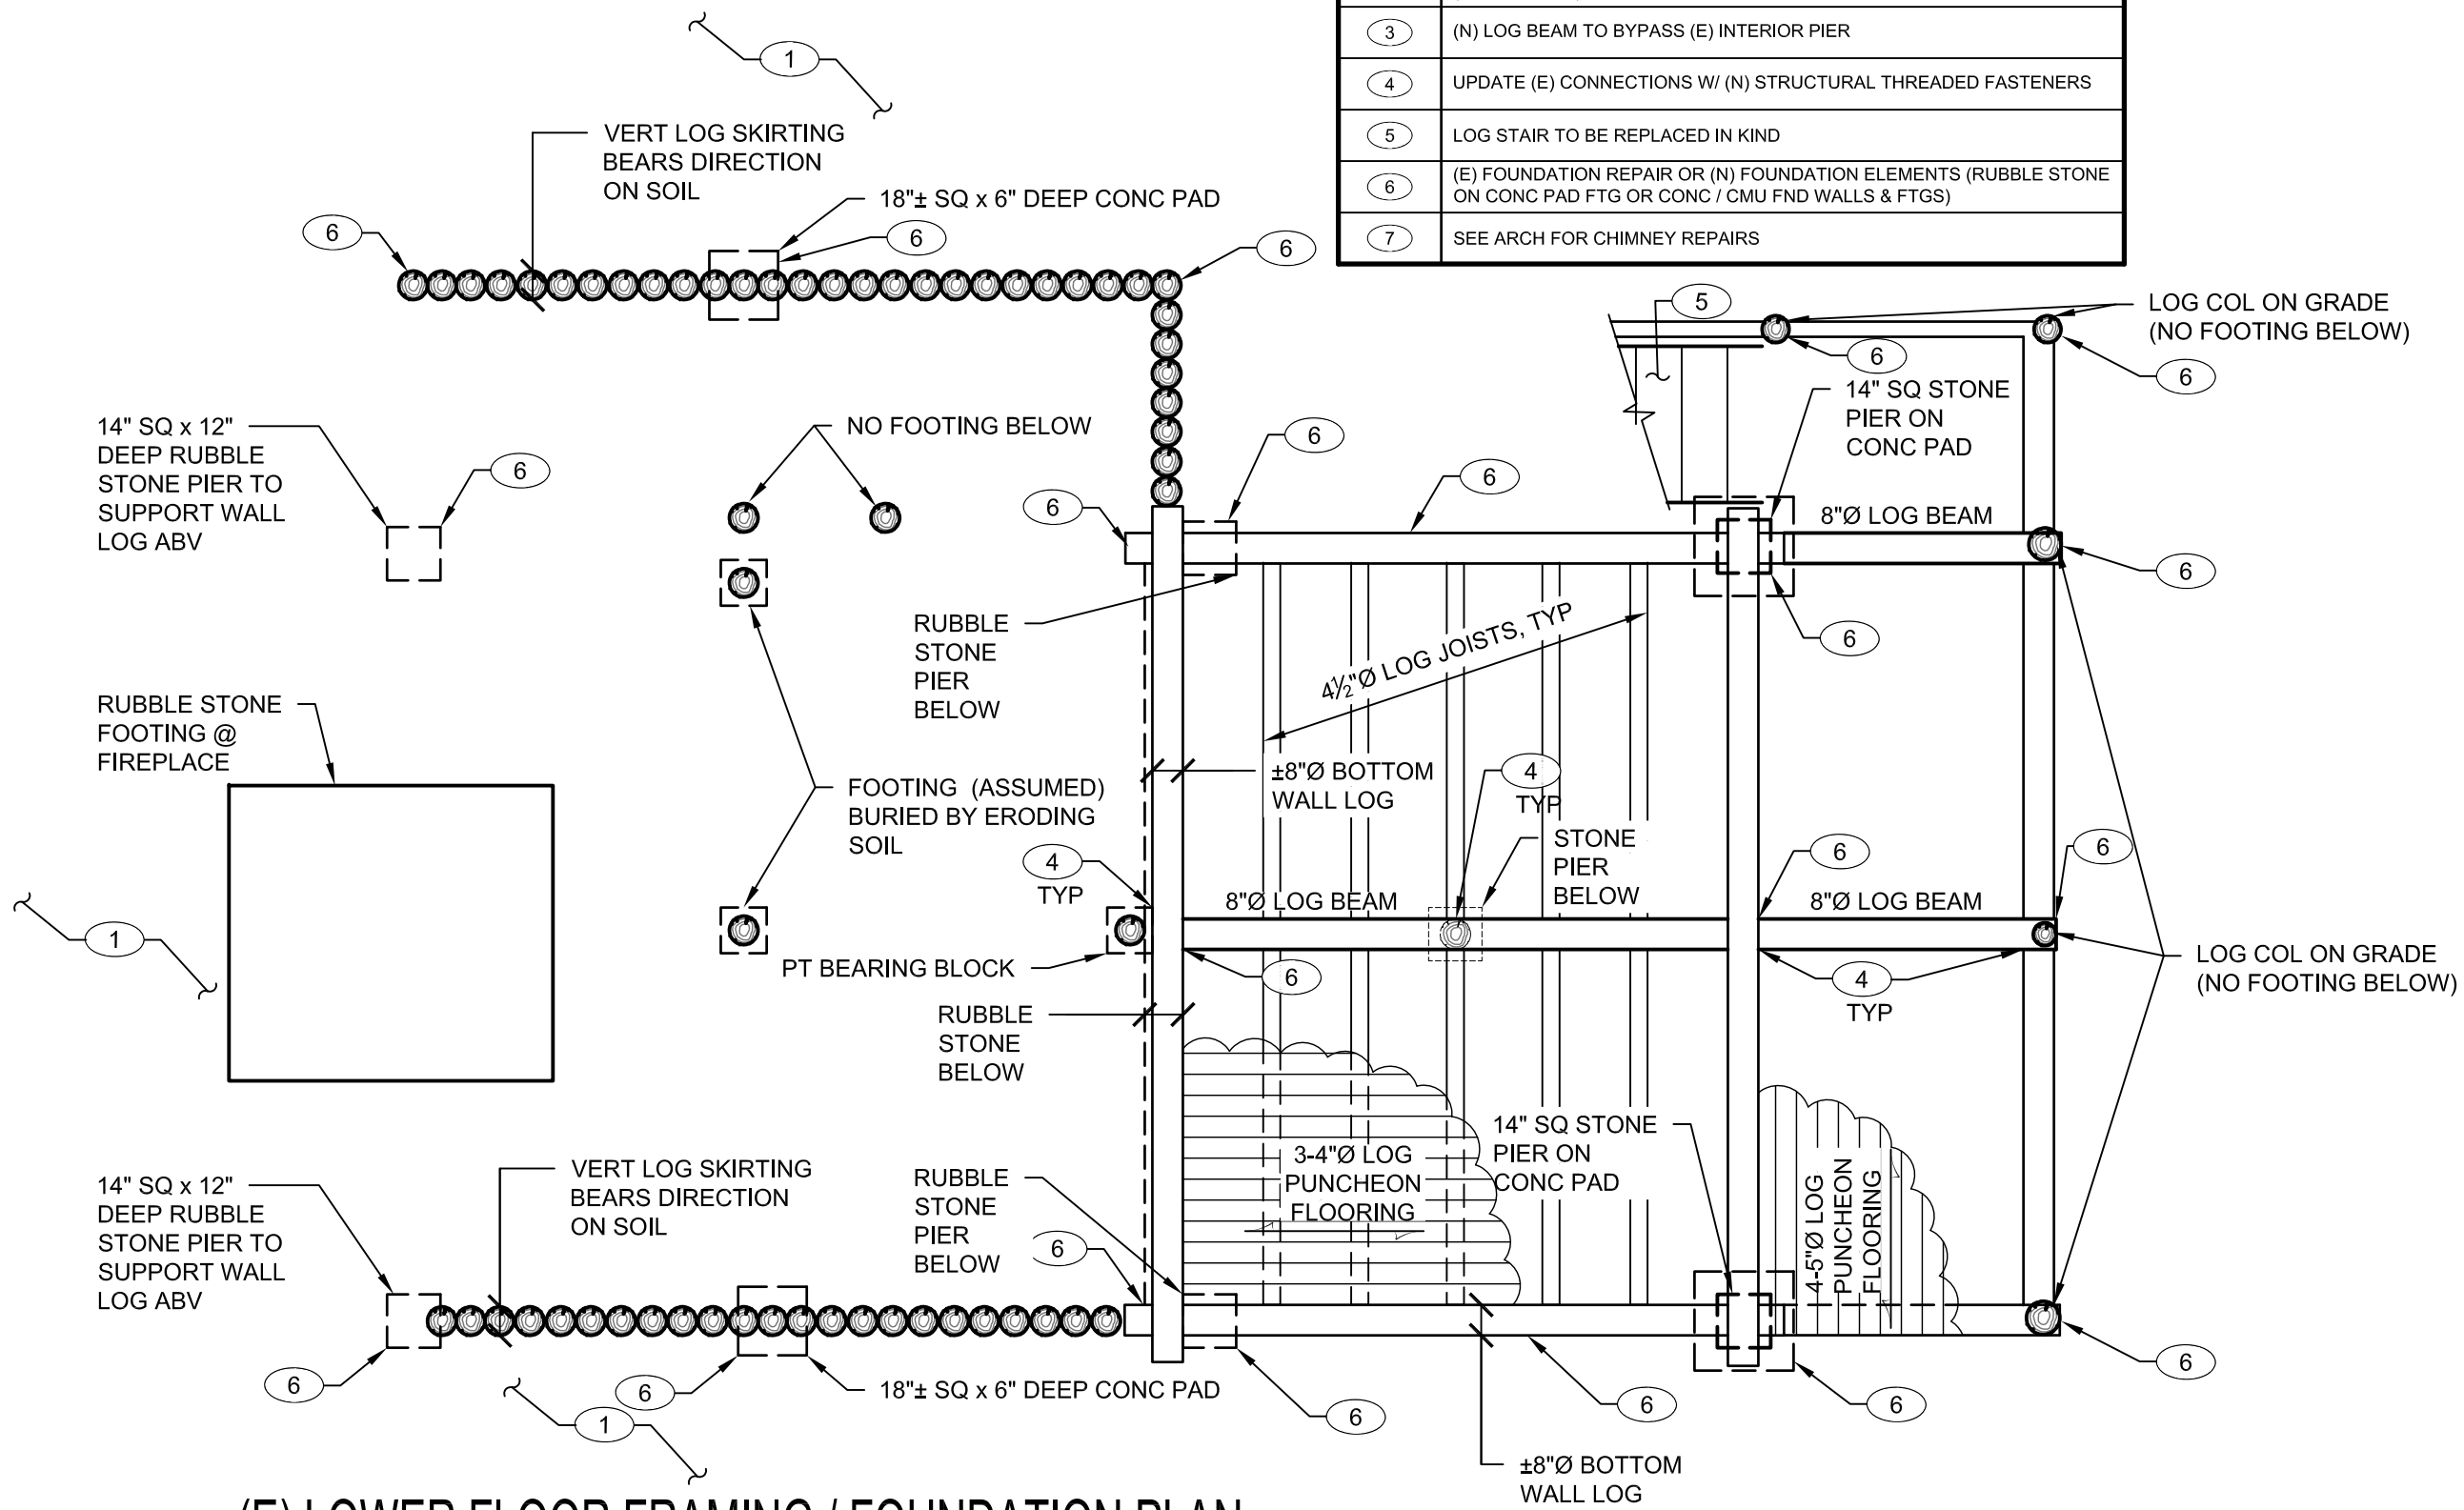
(E) LOWER FLOOR FRAMING / FOUNDATION PLAN

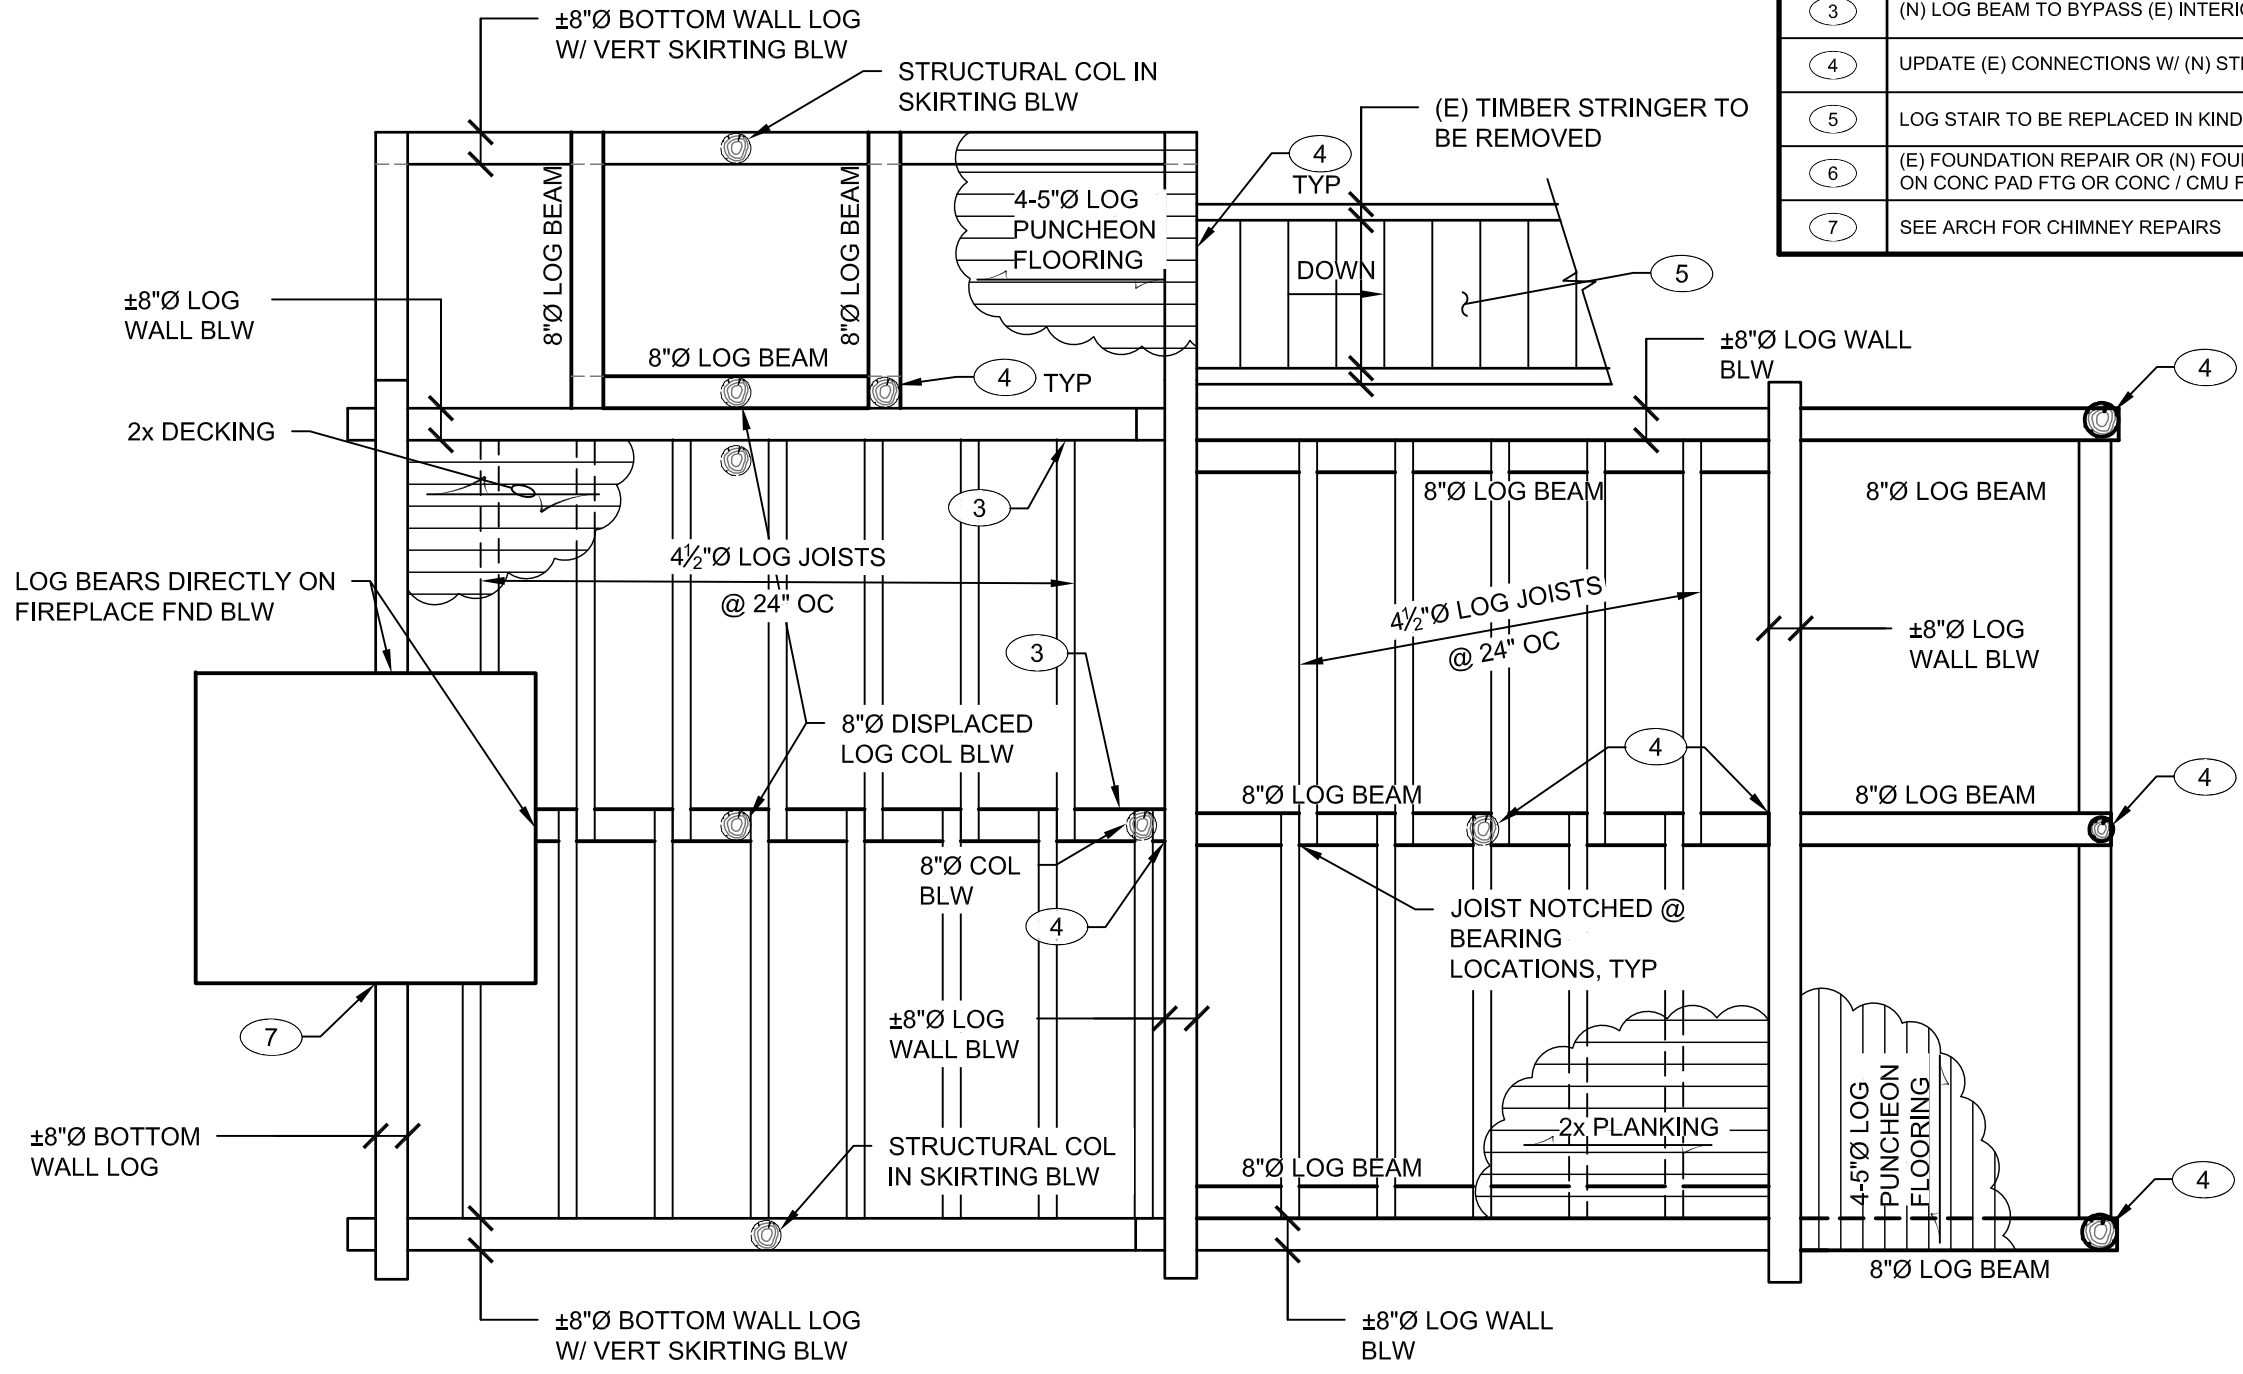
(E) UPPER FLOOR FRAMING PLAN
